REPORT FHWA/NY/SR-99/130

In-Service Performance Of HP Concrete Bridge Decks

IN-SERVICE PERFORMANCE OF HP CONCRETE BRIDGE DECKS

Special Report 130
February 1999

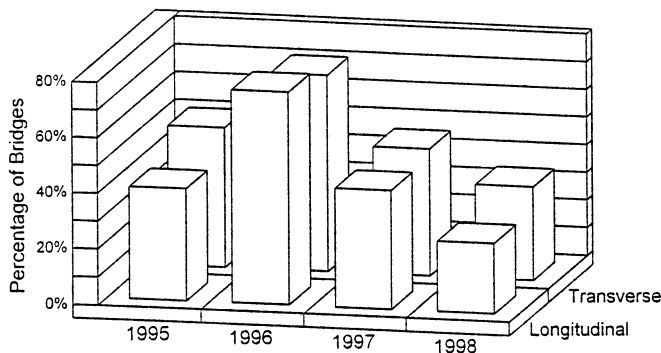
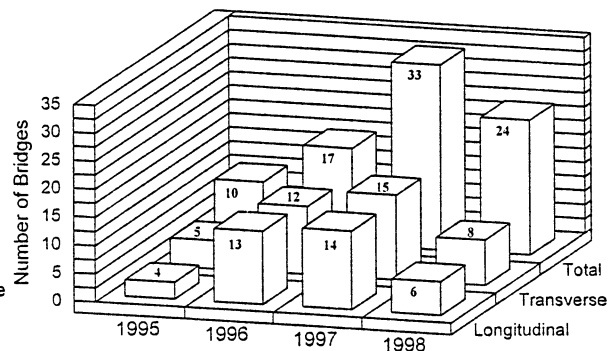
Figure 1. Occurrence of cracking in relation to year built.

In Figure 1B the first two rows of bars allow comparisons of successive annual numbers of decks showing longitudinal and transverse cracking. The back row represents total bridges inspected. Although use of Class HP began in 1996, several experimental decks had been built earlier, and were included in the inspection lists provided to the regions. No obvious correlation appears between years-in-service and cracking or cracking density, based on these data. Average cracking densities per year (in cm/m^2) are 9.0, 6.7, 4.2 and 5.0 for 1998, 1997, 1996 and 1995, respectively.

In 1995, ten test decks were built under supervision of the Materials Bureau. By 1996, HP concrete was in wide use. The 1996 peak in percentage of decks that exhibited cracking (Figure 1B), probably reflects that manufacturers, engineers-in-charge, and construction tradesmen were all at the beginning of their "learning curves" for this material. By 1997, quality of the decks, measured here by lack of cracking, increased as these participants became more familiar with the material. Numbers for 1998 seem to illustrate a leveling of the amount of cracking observed.

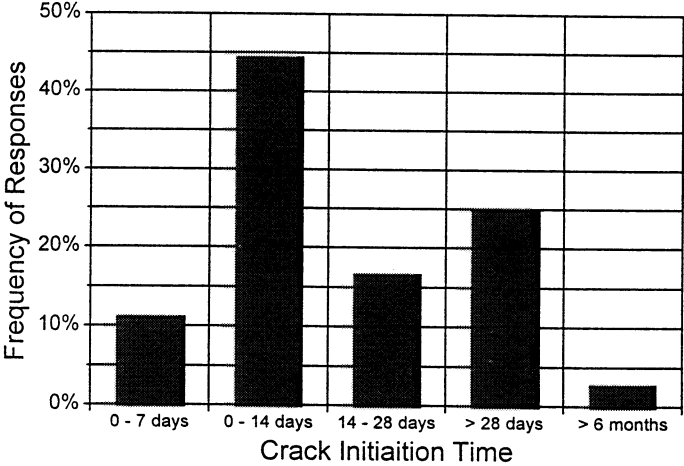
Figure 2. Initiation of cracking.

7. Time to first appearance of cracking was also surveyed -- most deck cracks appeared within two weeks after the concrete pour, as shown in Table 8 and Figure 2.
