REPORT FHWA/NY/SR-09/149

# **CENTERLINE (LONGITUDINAL) JOINT ADHESIVE PERFORMANCE: TWO TO THREE-YEAR REVIEW**

**SPECIAL REPORT 149**  
**TRANSPORTATION RESEARCH AND DEVELOPMENT BUREAU**  
New York State Department of Transportation  
Stanley Gee, Acting Commissioner

Special Report 149  
November 2009

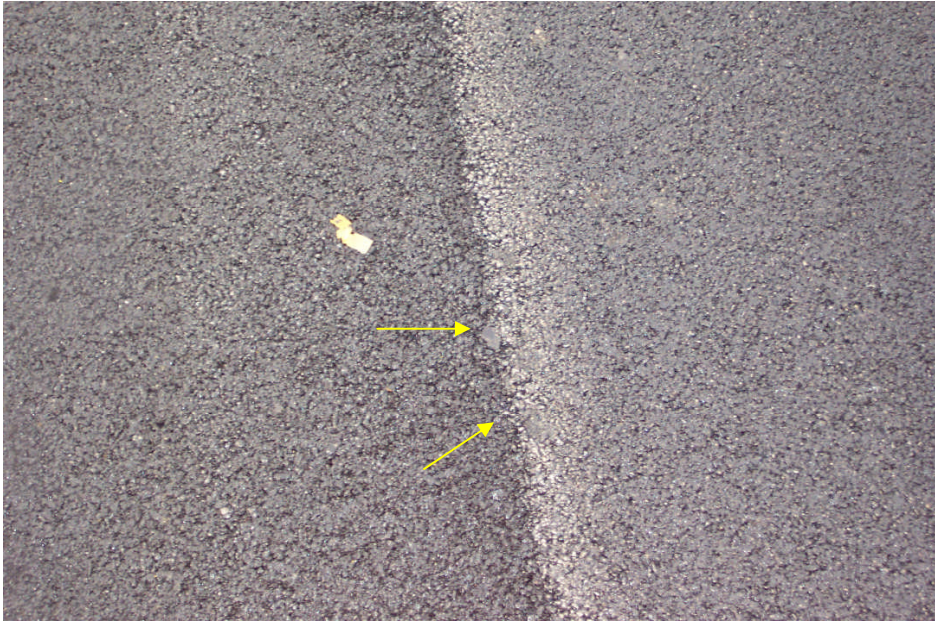
Adhesive was placed just prior to paving the second lane on all jobs except the Oswego County highways. On Routes 3 and 481, adhesive was placed the day before the second lane was paved meaning the longitudinal joint with adhesive in place was left open to traffic overnight. There appeared to be no concerns from construction or inspection personnel about leaving the joint and adhesive in this condition. When paving was done next morning, small spots (generally less than 1 inch diameter) of melted adhesive appeared at the surface along centerline in random areas, ensuring that the adhesive was being melted by the hot-mix asphalt being placed thus creating a seal along the longitudinal seam (Photo 9).

**Photo 9: Adhesive Beads @ Surface After Rolling**

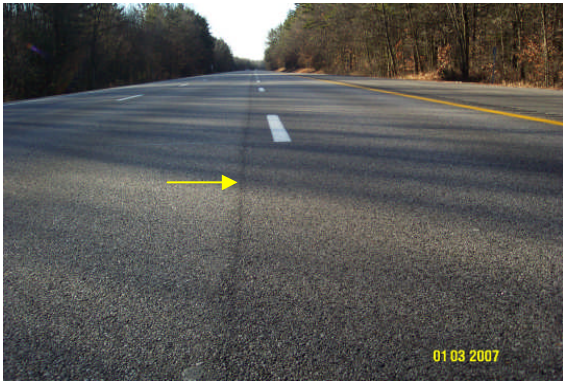
I87 was visited in January 2007 by Chris Euler and Rick Morgan (see Table 1 for locations). The entire length of the control section had a single crack (Photo 10). In the 2 inch bead section, approximately 40 percent of the centerline (Photo 11) was cracked while 80 percent of the 4 inch section was cracked (Photo 12). There are minor areas of ravelling appearing along the centerline of all three sections.

**Photo 10: Crack in Control Section – I87**

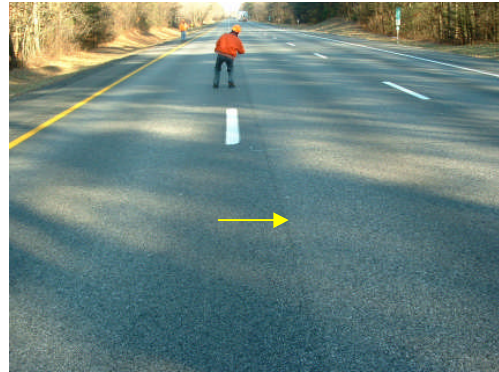
**Photo 11: Crack in 2 inch Bead Section – I87**

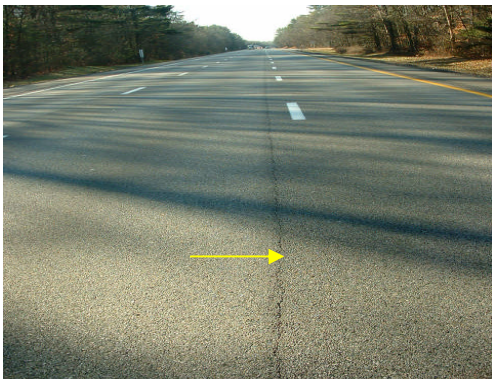
**Photo 12: Crack in 4 inch Section – I87**

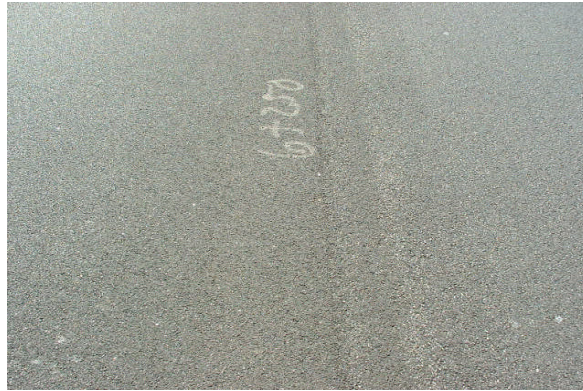
Route 3 was evaluated in January 2006 and 2007 by Chris Euler and in July 2006 by Rick Morgan (see Table 2 for locations). There is no control section on this route. In January 2006, the test section was examined and there was no cracking in the section. In July, the entire job was examined and there was no visible distress noted along entire length of the site (Photo 13). In 2007, the test section was again evaluated with no cracking visible.

**Photo 13: Good Centerline Seam – Route 3**

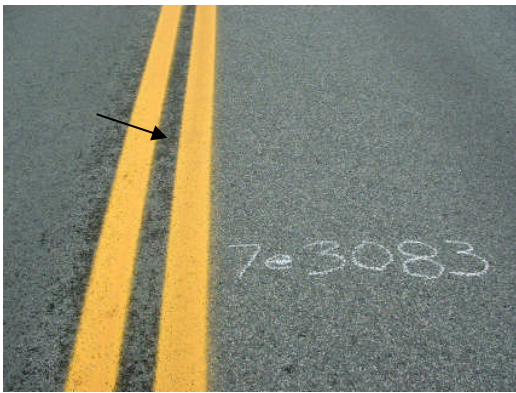
Route 7 was evaluated in September, 2006 by Rick Morgan and in January 2007 by Chris Euler (see Table 2 for locations). In 2006, the entire job was examined with approximately 20 to 25 percent of the centerline in the test sites was cracked (hairline to 1/4 inch wide, less than 3 feet to 250 feet in length, and varied depths). There were areas of ravelling along centerline in the test sites of varying lengths (similar to cracking lengths). In the control site more than 60 percent of the centerline was cracked with entire first 0.2 mile cracked. Crack widths, depths, and lengths in the remaining 0.4 mile, were similar to test sites. Areas of ravelling were also present along centerline in the control site (Photos 14 thru 16). In 2007, the test and control sections were evaluated. The test section had a single crack along 20 percent of its length while the control section had a single crack along approximately 80 percent of its length.

**Photo 14: Ravelling Along Centerline – Route 7**

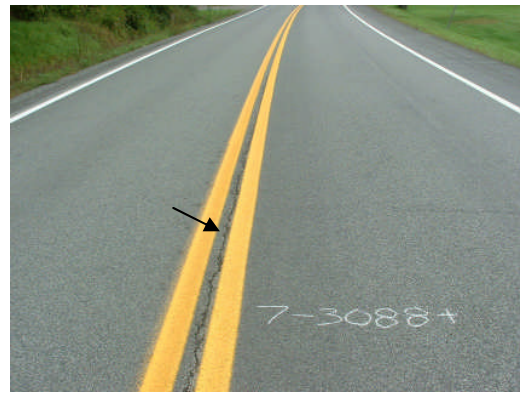
**Photo 15: Cracking in Adhesive Section – Route 7**

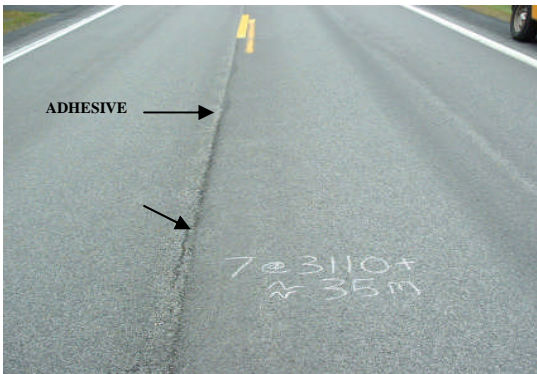
**Photo 16: Cracking & Adhesive @ Surface – Route 7**

All adhesive sites on all routes had areas at which adhesive was forced to surface during rolling. This demonstrates that during the rolling process, adhesive is forced into areas other than where it was placed thereby sealing more surface area within the seam. These areas at the surface varied in size from spots less than 1 inch diameter to beads up to 6 inches in length.
