REPORT FHWA/NY/SR-04/141

# In-Service Performance of an FRP Superstructure

# **IN-SERVICE PERFORMANCE OF AN FRP SUPERSTRUCTURE**

Special Report 141  
March 2004

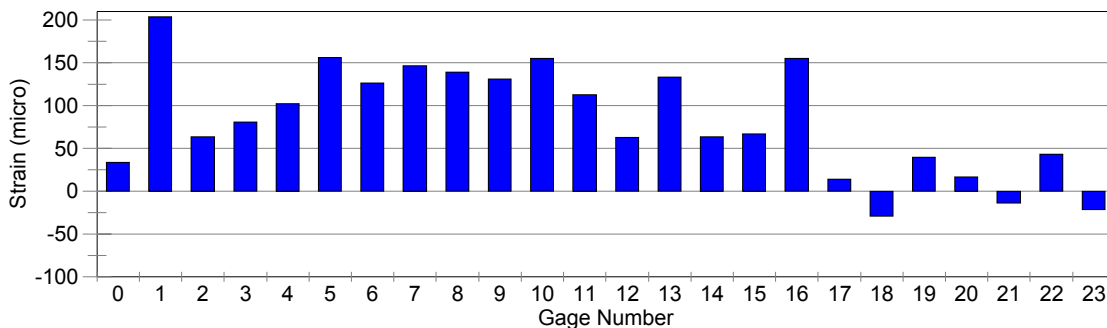
**Figure 6. Strain data under proof load (see Figure 3 for gage locations).**

The data from the load cases is generally consistent in the sequence and symmetry of the loading. The data also tends to show generally lower strains in the southeast portion of the bridge (gages 11, 14, and 17) than corresponding gages in other quadrants. This may be attributed to a greater fixity of the superstructure to substructure connection in the southeast quadrant due to variations in drilling and grouting of the anchor bolts during construction.

The maximum strain recorded was considerably less than the approximately  $600 \mu\epsilon$  predicted by the analysis conducted by the manufacturer (see Figure 6 and Table 2). This indicates a significantly higher load capacity than that originally assumed (3). The maximum deflection at mid-span during Case 4 was measured to be less than 3.5 mm, which is considerably less than the  $\text{Span}(L)/800$  design limitation of 8.8 mm.

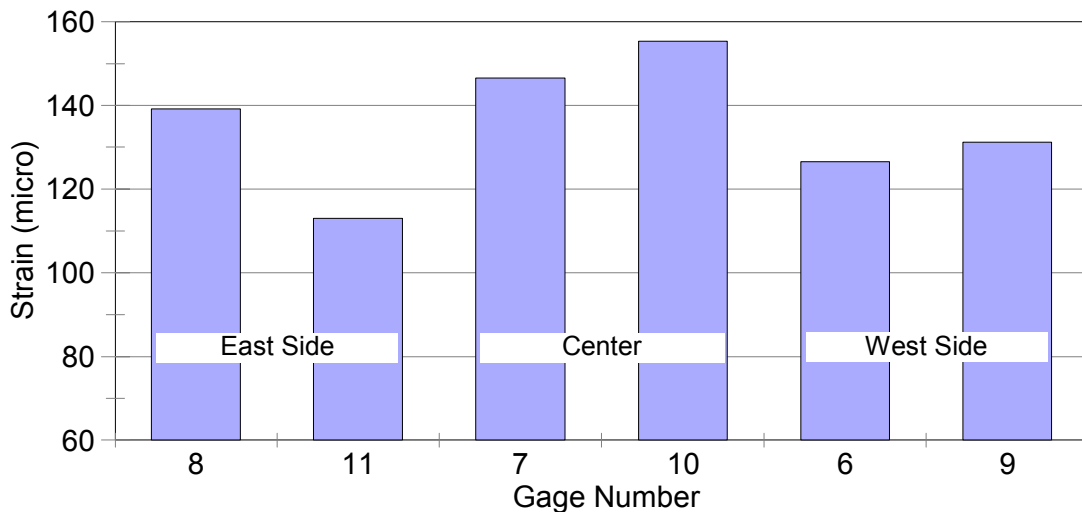
**Figure 7. Strains from gages on both sides of the shear-key.**

An examination of the data (from Case 4) from the gages located along the centerline showed generally consistent results between adjacent pairs of gages located across the centerline longitudinal joint (see Figure 7 and Table 3). Based on this, it can be concluded that the loads were being effectively transferred across the centerline longitudinal shear key.

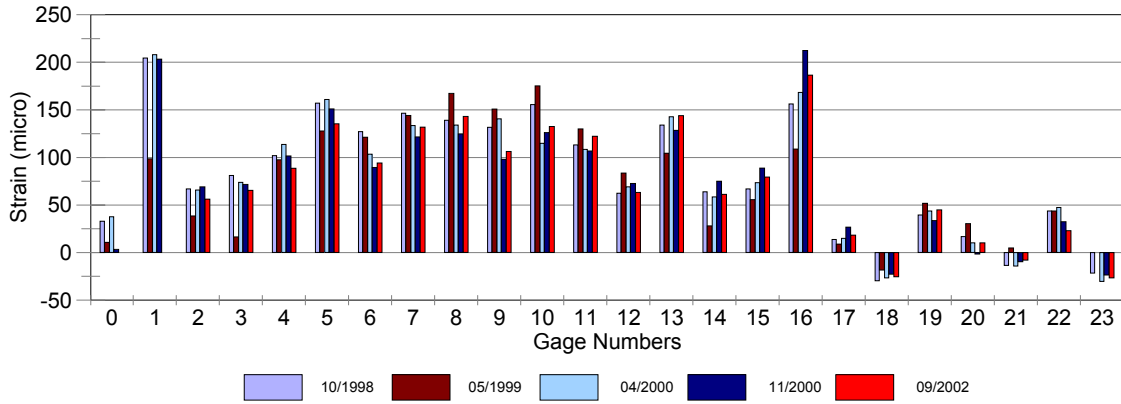
**Figure 8. Strain data under proof loads over four years.**

The results indicate that the strain data from subsequent tests compare well to the initial proof-load test data, indicating that the FRP slab bridge is performing well in-service as expected without any structural problems. The data also indicate that the shear-key is performing well. The same conclusion was reached using LVDTs placed along the centerline (Figures 11-12 and Tables 8-9).

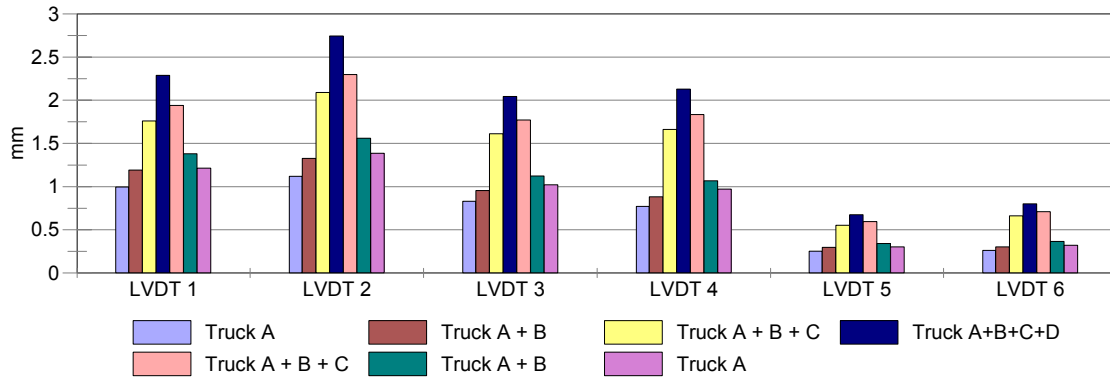
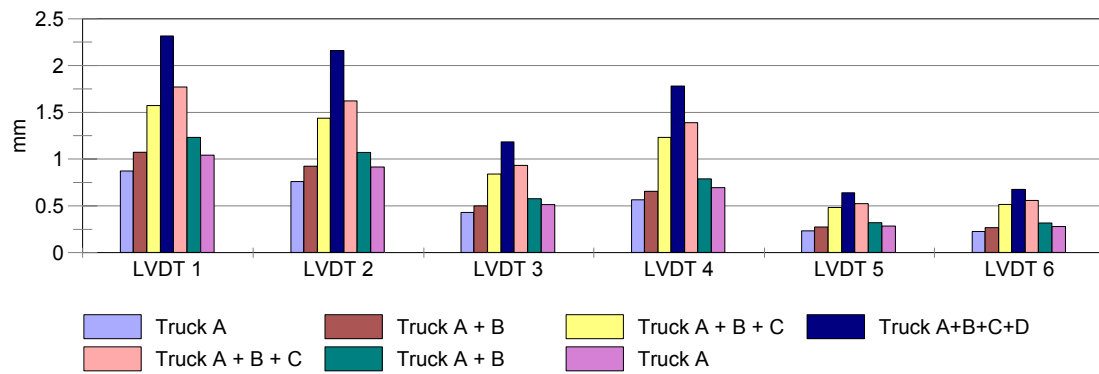
Figure 11. Deflections on both sides of the shear-key during April 2000 load test.

Figure 12. Deflections on both sides of the shear-key during November 2000 load test.

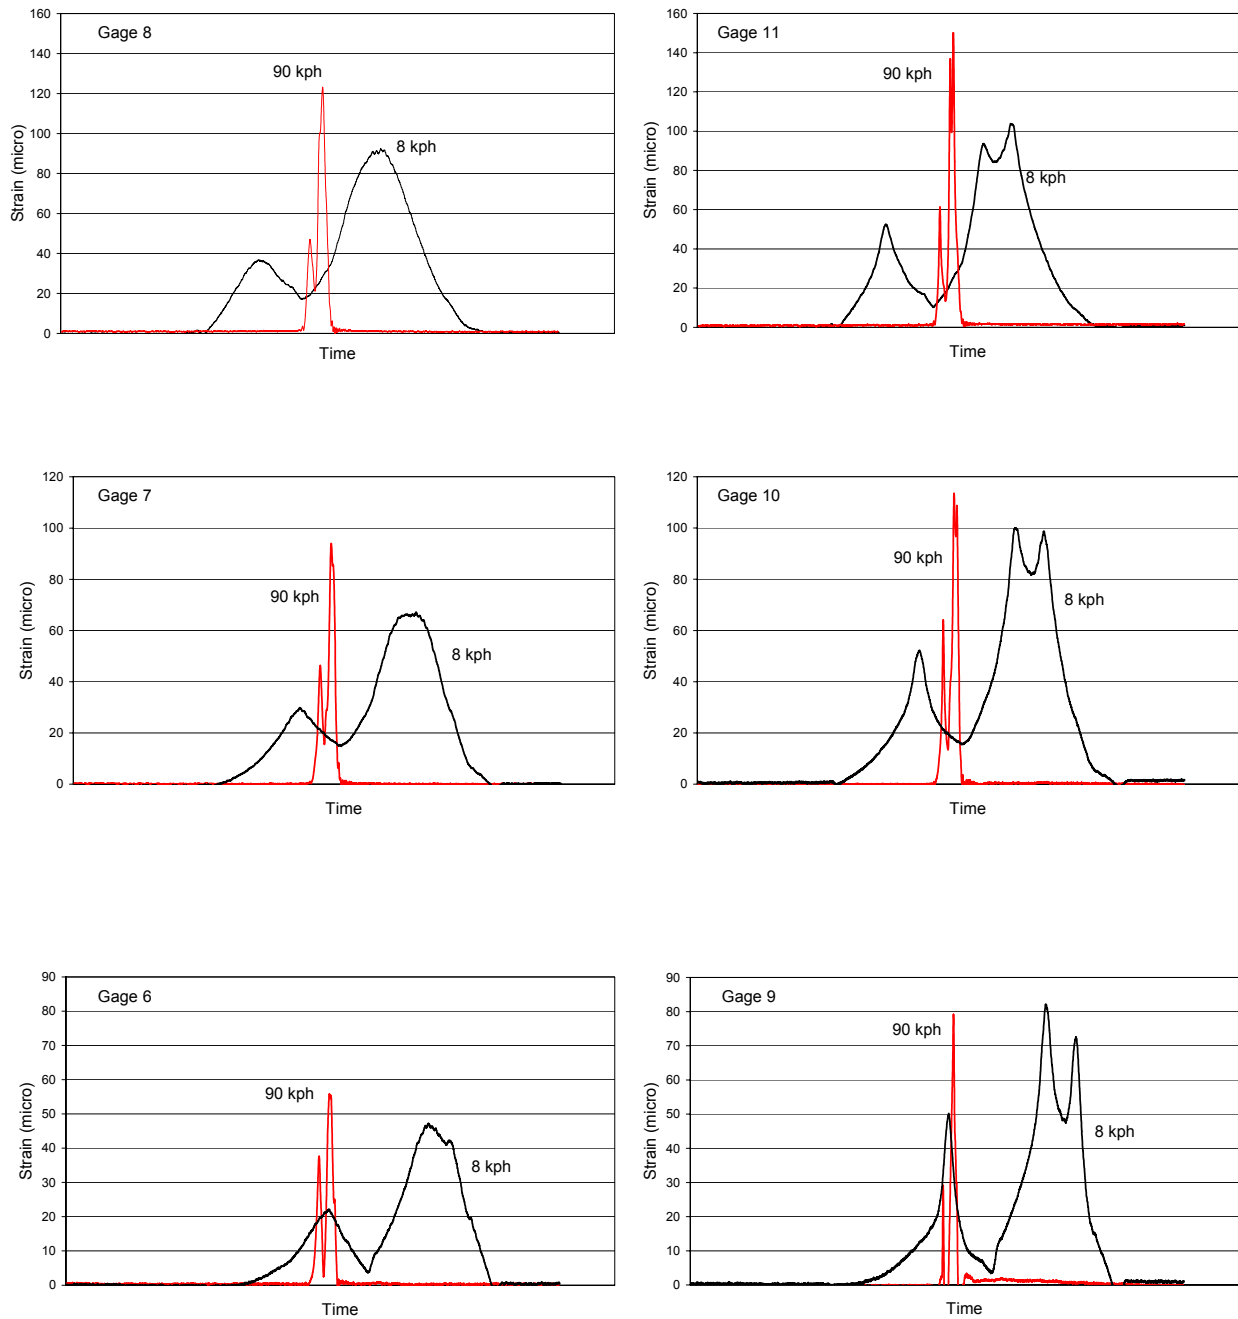
Figure 13. Data from dynamic tests.

Static response induced by a loaded truck “crawling” across the bridge at about 8km/hr (5 mph) was used as a reference. The same loaded truck was driven across the bridge at the posted speed limit (90 km/hr or 55 mph). The maximum measured response induced by the vehicle was divided by the maximum static response (obtained at crawl speed) to obtain the impact factor. Data was from six different gages and the impact factors varied from 0.06 to 0.52 (see Figure 13 and Table 10). Note that a running average was used to smooth the plots shown in the Figure 13. Consequently, the peak values may appear different than actual peak values reported in Table 10.

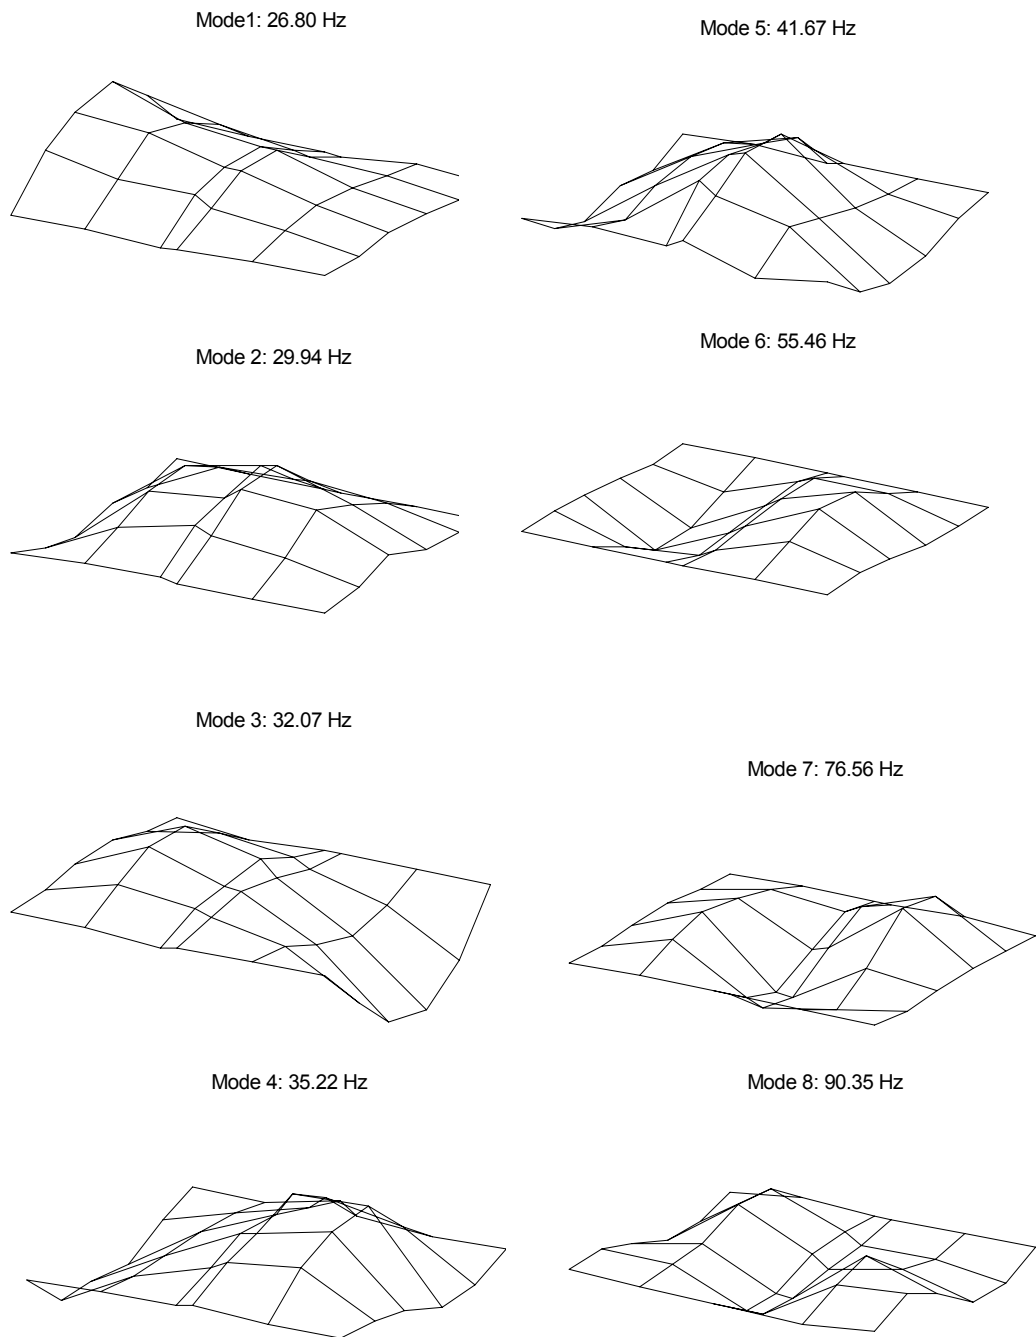
**Figure 15. Mode shapes of the FRP Superstructure.**

The frequency and damping values for the first 8 modes are presented in Table 11 and the mode shapes are shown in Figure 15. The mode shapes exhibited the characteristics of a plate with continuity near the longitudinal joint, confirming the effectiveness of the longitudinal shear-key. The magnitude of the motions at the abutments indicate that the superstructure is well anchored and a near fixed condition exists instead of the simply-supported boundary conditions assumed in the preliminary finite element analysis. The vibration absorbing capacity of FRP superstructure is also reflected in the damping values, which are higher than those for typical steel structures.

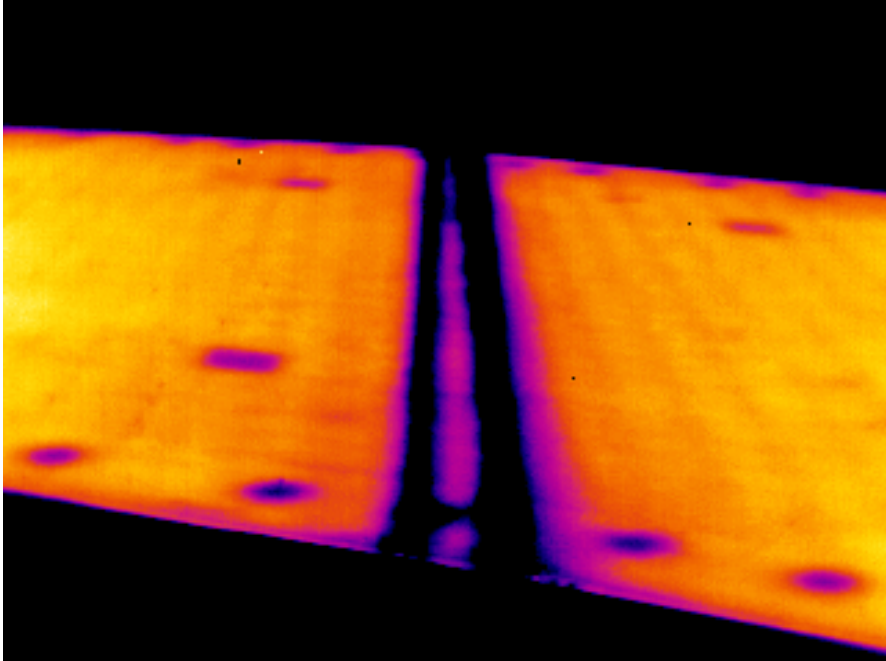
**Figure 16. Infrared photo of the deck top surface.**

The Infrared Thermography as a means to evaluate the slab integrity is under review. The limitations and sensitivity of this nondestructive test method in detecting the damage in the deck is being explored. A typical picture, of the top surface of the deck, taken using an infrared camera is shown in Figure 16.
