Load Testing of An FRP Bridge Deck On A Truss Bridge

SPECIAL REPORT 137
TRANSPORTATION RESEARCH AND DEVELOPMENT BUREAU
NEW YORK STATE DEPARTMENT OF TRANSPORTATION
George E. Pataki, Governor/Joseph H. Boardman, Commissioner

Special Report 137
July 2001

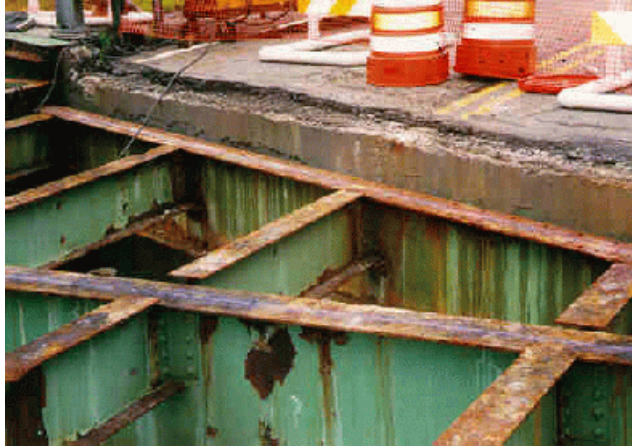
Figure 2. Corrosion of steel superstructure at the south abutment.

rating of the deck was 3, on a scale of 1 to 7 used in New York State (see Table 2), indicating serious deterioration. The steel trusses were found to be in relatively good condition even though the superstructure was built in 1940. The minor deterioration was attributed to leakage of water laden with de-icing salts. The load posting had a negative impact on local commerce and restoring the bridge to full service was imperative. Exploration of rehabilitation alternatives began in 1998.

1. Removal of the concrete deck and the sidewalk,
2. Steel repairs (i.e. replacing rusted rivets with bolts, fish-plating areas of section loss, etc.),
3. Installation of temporary deck grating,
4. Cleaning and painting of steel superstructure,
5. Removal of temporary grating and installation of light-weight FRP deck (see Figure 5), and
6. Replacement of approach and bridge railings (see Figure 6).

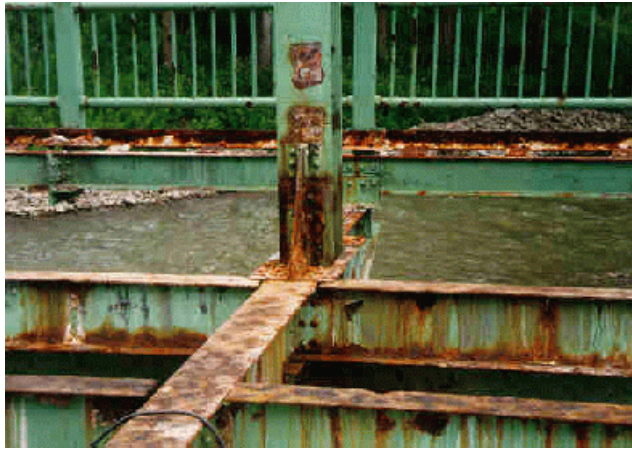
Figure 3. Corrosion at the floor-beam to truss connection.

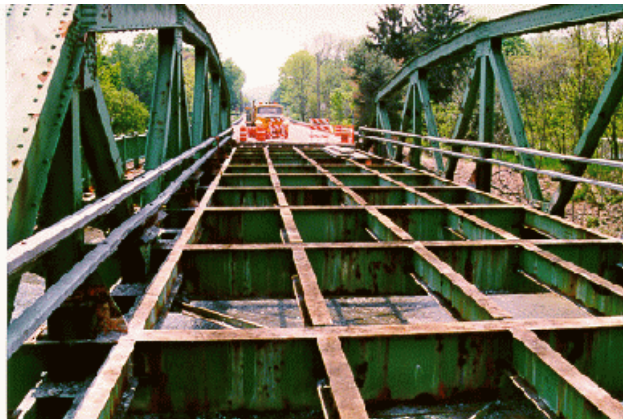
Figure 4. Corrosion of floor-beams.

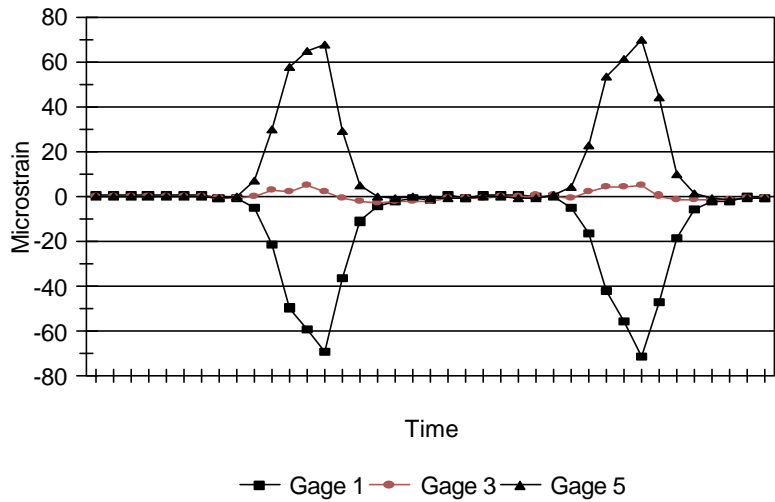
Strain gages 0, 1, 2, 3, 4, and 5 were mounted on a steel floor-beam supporting the FRP deck (see Figure 9) to determine neutral axis of the deck-floor-beam system. Gages 0 and 1 were mounted to the upper flange, gages 2 and 3 were mounted on the web at mid-height of the girder (at the neutral axis of the floor-beam), and gages 4 and 5 were mounted to the lower flange. If there is no composite action between the floor-beam and the deck, neutral axis of the deck-floor-beam system should coincide with the neutral axis of the floor-beam. In this situation, Gages 2 and 3 should read no flexural strains; and top flange gages (0 and 1) and bottom flange gages (4 and 5) should read strains of same magnitude with opposite signs (positive for tension, and negative for compression). Data collected from Gages 1, 3, and 5 during Load Cases 1 and 2 are shown in Table 4. The results show that the strains in bottom and top flanges are almost the same except for the sign (as expected) and represent a mirror image, with negligible strain at the center of the girder. The data indicates that the neutral axis of the girder is unchanged with the addition of the FRP deck and no composite action exists between the deck and the floor-beams. Redundant Gages 0, 2, and 4 confirmed this observation. The same behavior can be seen in the data collected during the passage of a truck rolling at 5 km/hr across the bridge (see Figure 15).

Figure 15. Gages on steel floor-beam during the 5km/hr rolling tests.

This validates the deck design, which assumed no composite action between the deck and the floor-beams, and the effectiveness of the connection system used to fasten the FRP deck to the floor-beams.

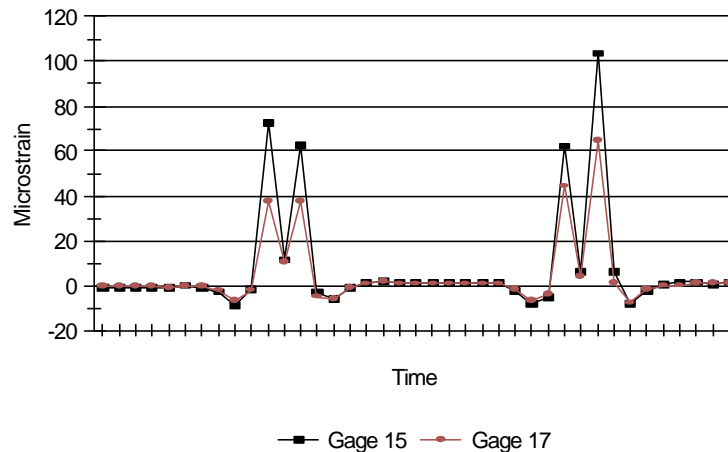
The deck panels were connected to each other with epoxy resin on the vertical faces as well as top and bottom FRP cover plates. There is no other mechanical shear-key mechanism. Hence to study the effectiveness of the joints, strain gages were installed on both sides of the longitudinal joint and loaded trucks were positioned in both lanes of the structure (Load Case 1 - see Figure 12), one truck at a time. The data from this load case is shown in Table 5. If the joint is transferring the loads effectively, strains recorded by the gages on either side of the longitudinal joints should be equal. With one truck located on deck panels on each side of the joint, (the case of Trucks A+B), both the gages read similar strains as expected since the trucks have near equal weights. When the load is only on one side of the joint, the readings changed noticeably. The data shows that the joint is transferring approximately 65 to 70% of the load. The same trend can be observed using the data obtained from semi-static load testing (see Figure 16). These results indicate that the longitudinal joint is transmitting loads from one deck segment to the other, but the load is not completely carried across the joint. Since the deck joints were new at the time of the testing, it is recommended that testing be repeated after a few years to determine if in-service loads and environmental conditions have degraded the joint effectiveness.

Figure 16. Gages both sides of the longitudinal joint during the 5km/hr rolling tests.
