**HYBRID FRP-CONCRETE BRIDGE  
DECK SYSTEMS  
Project No.: C-02-07**

**FINAL REPORT II:  
LONG TERM PERFORMANCE OF HYBRID FRP-  
CONCRETE BRIDGE DECK SYSTEM**

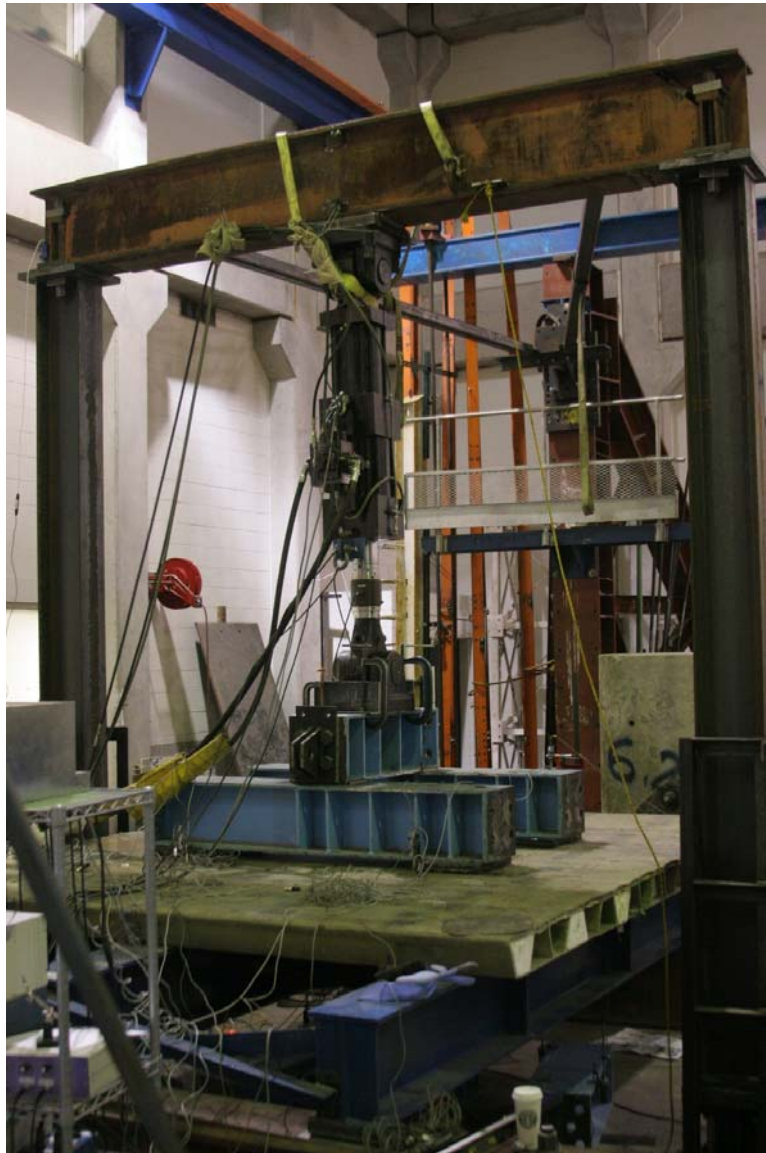
**Fig. 4.1** Photograph of fatigue test setup

The experimental setup for the fatigue testing program was designed to enable subjecting the HFRPC-SG specimen to 2 million cycles of vertical loading with amplitude of 165 kN (1.33 times the scaled tandem load). A photograph showing the experimental setup for the fatigue testing program is presented in Fig. 4.1. Figures 4.2 and 4.3 present schematics of the experimental setup that consisted of the HFRPC–SG specimen (including HFRPC deck and steel girders) simply supported on two W760x284 transverse support beams, a spreader frame to simulate a two axle truck, four 383 mm by 290 mm steel plates with bonded rubber pads to simulate truck tires, a 500 kN (110 kip) MTS 244.41 hydraulic actuator and a vertical reaction frame consisting of two W310x60 columns and a W460x158 transverse beam. The vertical planar reaction frame is braced in the lateral direction (north-south) via two HSS steel sections connected to an existing steel reaction frame in the Structural Engineering and Earthquake Simulation Laboratory (SEESL) [see Fig. 4.2]. Load was applied via the hydraulic actuator to the HFRPC deck through the spreader frame and the four steel-rubber pads. The spreader frame and steel

pads were designed to simulate the dimensions and loading of the tandem load specified in the 1998 AASHTO LRFD Bridge Design Specifications (AASHTO 1998) scaled according to the 3/4 model length scale factor. Each steel-rubber pad consists of a steel plate 25 mm thick bonded to a rubber pad 12.5 mm thick each with plan dimensions of 383 mm by 290 mm and arranged in a two-axle truck configuration with 0.9 m between each axle (north-south) and a width of 1.35 m (east-west).

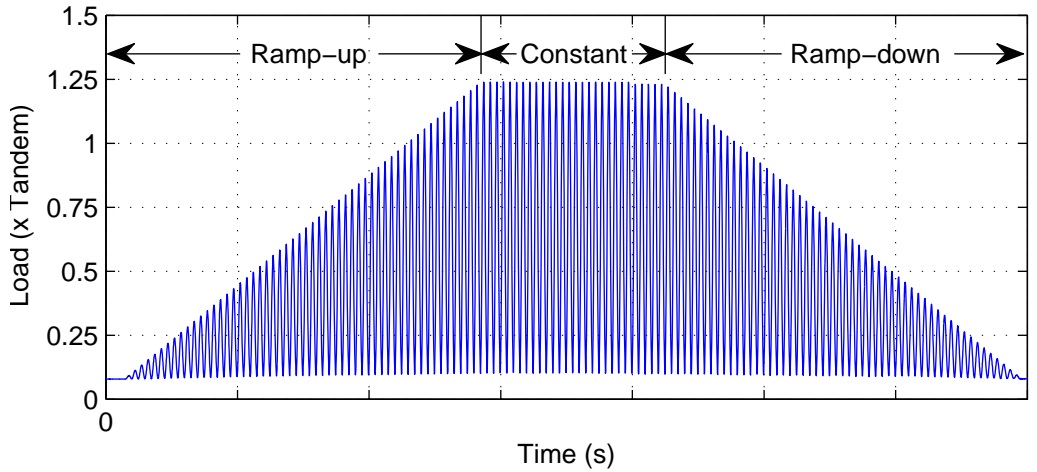
a. Three-phase loading scheme

b. Portion of the Ramp-up phase

**Fig. 4.6 Three phase loading scheme used for fatigue testing**

consisted of sinusoidal loading with amplitude of 156 kN for the daily duration of testing (ranging from 3-1/2 hours to 13 hours). The Ramp-down phase consisted of 54 cycles of decreasing amplitude sinusoidal cycles until the structure was effectively un-loaded. For the purpose of cycle counting the Ramp-up and Ramp-down phases were ignored using only the Constant amplitude duration and the 2 Hz frequency to determine the daily number of cycles conducted. At intervals of 200,000 cycles, a static test was performed to collect data and to determine the stiffness and composite behavior of the HFRPC-SG systems. Each static test consisted of loading the HFRPC-SG specimen from a preload of approximately 9 kN up to 156 kN (1.26 x Tandem Load) and back to the 9 kN preload. Results of the static tests were used to investigate the fatigue resistance of the HFRPC-SG specimen and are presented in the subsequent results section.

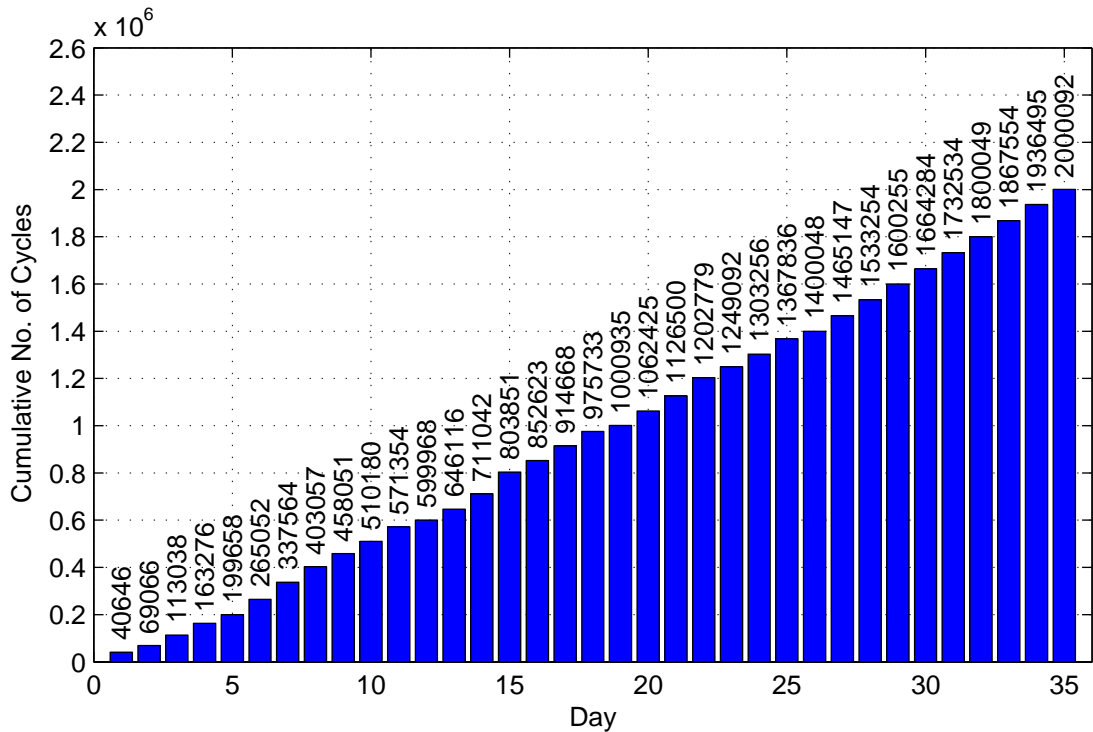
**Fig. 4.7 Loading history of fatigue test**

The peak load amplitude for the fatigue testing was decreased from the target value of 1.33 times the scaled tandem load (165 kN) to approximately 1.26 times the scaled tandem load (156 kN) to ensure the 2 Hz loading frequency could be maintained by the hydraulic actuator in a stable manner throughout the duration of testing. For consistency the static “benchmark” tests were also conducted to a peak load amplitude of 1.26 times the scaled tandem load or 156 kN. Although the load amplitude of 1.26 times the scaled tandem load is less than the desired 1.33 times the scaled tandem load that was chosen to account for the AASHTO impact factor the achieved load level of 156 kN is significantly (26 percent) larger than the scaled tandem load of 124 kN.

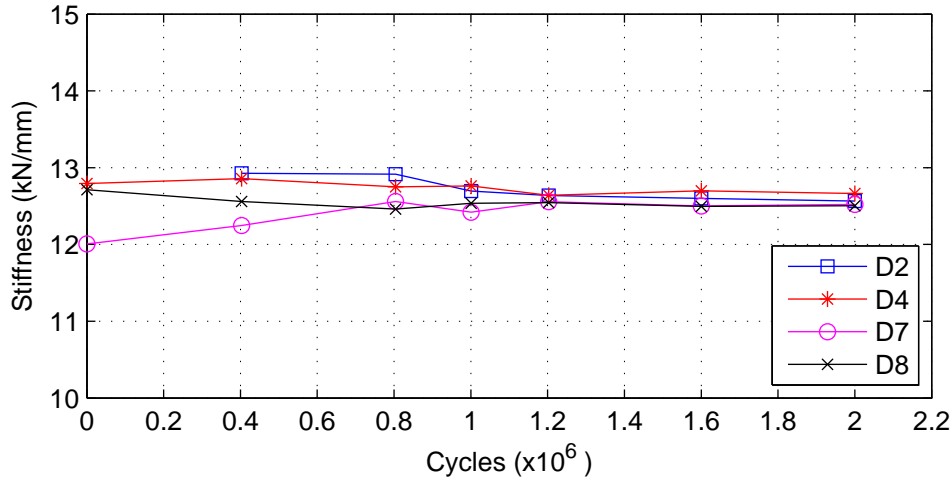
**Fig. 4.11 Vertical stiffness results for the HFRPC bridge deck**

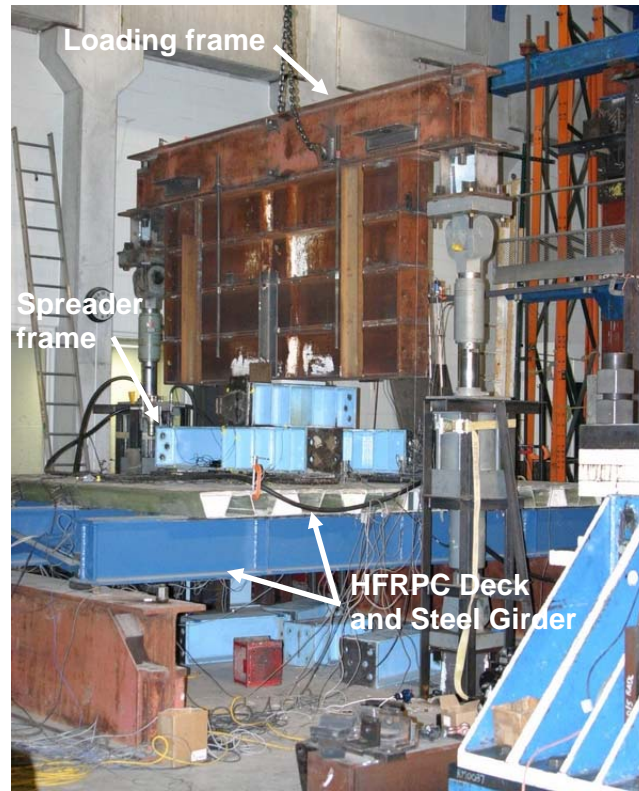
**Fig. 5.1 Photograph of destructive test setup**

The fatigue testing experimental setup (see Section 4) was designed specifically for the fatigue testing protocol (high frequency low amplitude loading) and therefore does not have sufficient capacity to reach the anticipated load level required to fail the HFRPC deck. To facilitate destructive testing of the HFRPC bridge deck an experimental setup with sufficient capacity used in previous verification tests performed on the HFRPC-SG specimen was utilized. A photograph of the experimental setup is presented in Fig. 5.1 showing the HFRPC-SG specimen, the loading frame, spreader frame and the two hydraulic actuators used to load the specimen.

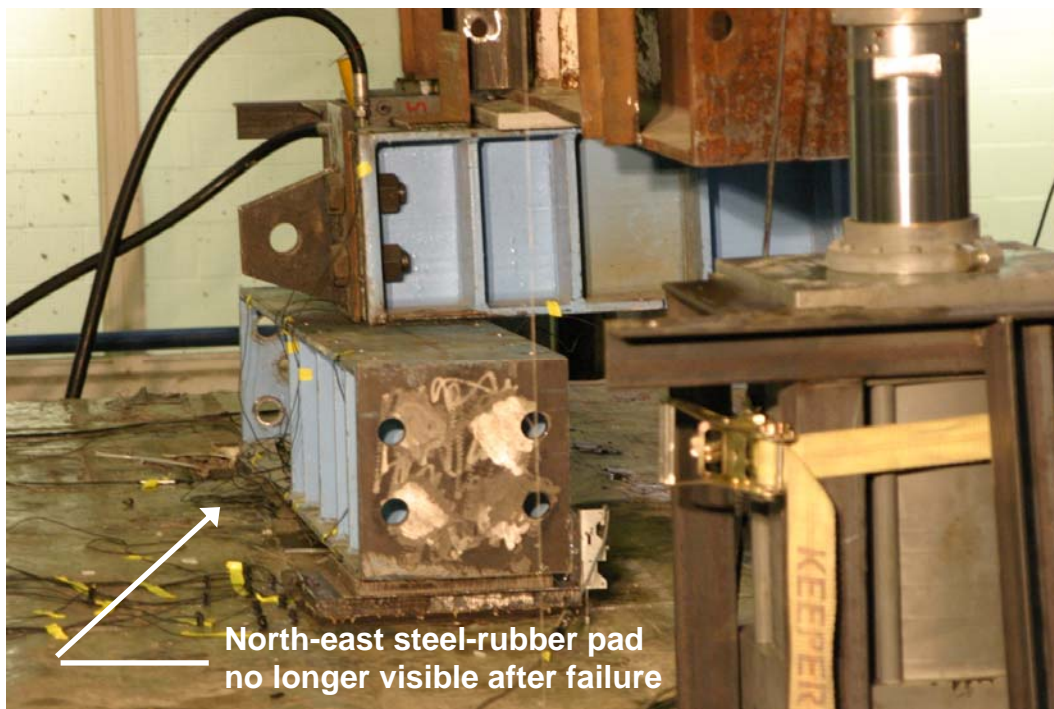
**Fig. 5.5 Photograph of spreader frame and failure at north-east load point**

9. At 7,500 seconds and a load of 623 kN (5xTandem) significant rotation of the loading frame about the east-west axis was observed accompanied by severe twisting and rotation of the spreader frame about the north-south axis due to failure of the HFRPC bridge deck at the north-east location as shown by the photograph presented in Fig. 5.5.

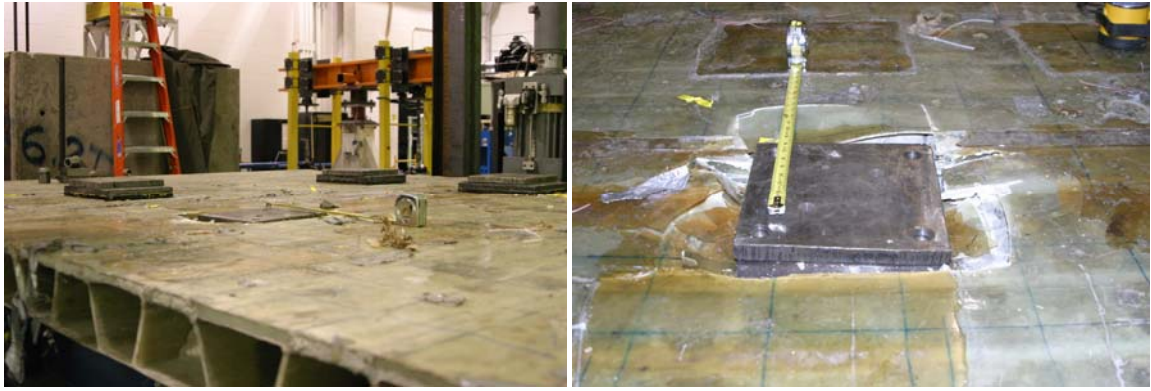
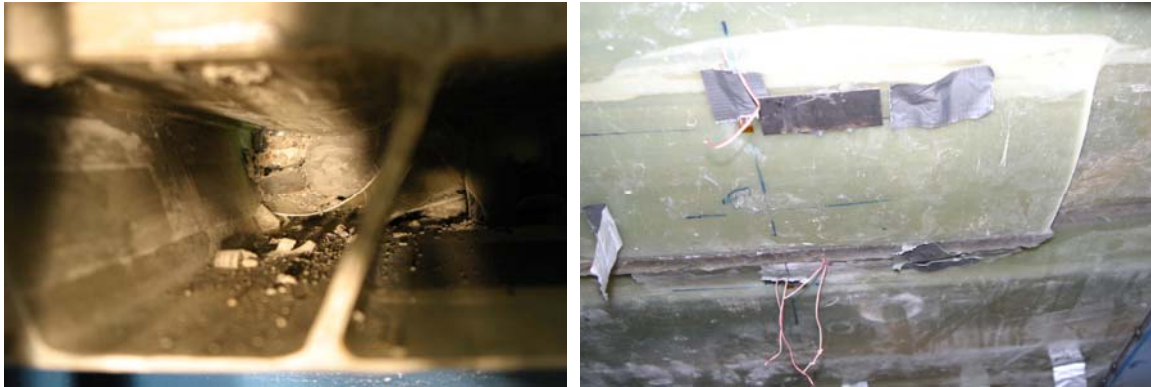
a. HFRPC deck surface

b. failure of deck at north-east location

c. failure of inclined web

d. underside of HFRPC deck

**Fig. 5.6 Photographs of HFRPC failure at north-east point of loading**

Following the conclusion of the destructive test the loading frame and spreader frame were removed to facilitate post-test inspection of the HFRPC deck and steel girders. No noticeable global residual deformation was observed suggesting that the girders remained elastic or nearly elastic. The most notable failure occurred in the HFRPC deck at the north-east loading point where the rubber-steel pad punched through the HFRPC top flange into the HFRPC deck cavity as shown in the photographs presented in Fig. 5.6a and Fig. 5.6b. Figure 5.6a also shows the rubber-steel pads at the other three loading locations remained atop the HFRPC deck. Closer inspection revealed crushing of the concrete and failure of the inclined web at the north-east location over a length approximately equal to the width of the steel-rubber pad (250 mm) that is shown in the photograph presented in Fig. 5.6c. Further inspection of the underside of the HFRPC deck showed impending punching shear failure of the bottom FRP flange of the deck that is shown by photograph presented in Fig. 5.6d.

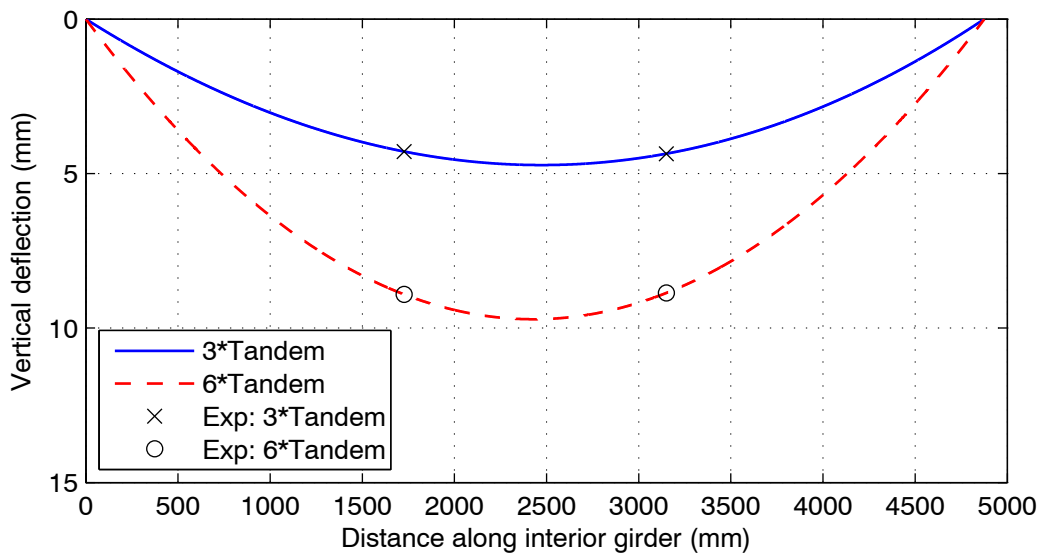
**Fig. 5.9 Deformed shape of the interior girder**

To verify the Rayleigh-Ritz method was generating reasonable deformed shapes, i.e. shapes that conform to the boundary conditions and specified displacements, the deformed shape profile of the interior girder was plotted for two load levels, specifically 3 and 6 times the tandem load. Figure 5.9 presents the deformed shape for 3 and 6 times the tandem load determined using the Rayleigh-Ritz method shown by solid and dashed lines respectively along with vertical displacement data from D5 and D26 shown by an x-shaped marker and a circle marker. The profiles plotted in Fig. 5.9 indicate that the Rayleigh-Ritz method appears to have provided reasonable estimates based on the zero displacement boundary conditions and the agreement between the measured and calculated displacements at the D5 and D26 locations as would be expected. Further verification of the Rayleigh-Ritz method is provided in the subsequent section when the elastic stiffness of the HFRPC-SG specimen determined from destructive testing is compared with the elastic stiffness determined from fatigue testing (see Section 4) where the vertical displacement of the center of the interior girder was measured directly.
