**WHEEL INSPECTION SYSTEM ENVIRONMENT
QUALIFICATION AND VALIDATION**

Final Report for Public Distribution

NYSERDA Project #9816

Final Report

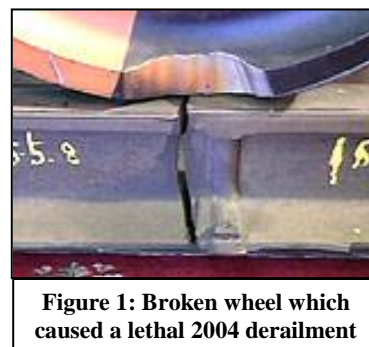
Figure 1: Broken wheel which caused a lethal 2004 derailment

Wheel inspection, maintenance and replacement are among the most important duties of a railroad mechanical department. Wheels are the most expensive component of freight car maintenance and account for about two-thirds of the lifetime cost to maintain¹. According to the Association of American Railroads (AAR) data, last year railroads spent about \$330 million to replace 320,000 wheelsets with tread damage. Since they are subject to high stress and wear during use, train wheels require a substantial amount of routine inspection, repair, and replacement. A high standard of maintenance is essential to avoid damage to track, cars and contents from rough, broken or deformed wheels. More importantly, the failure of a single wheel can result in a derailment with potentially catastrophic consequences (See **Figure 1**).

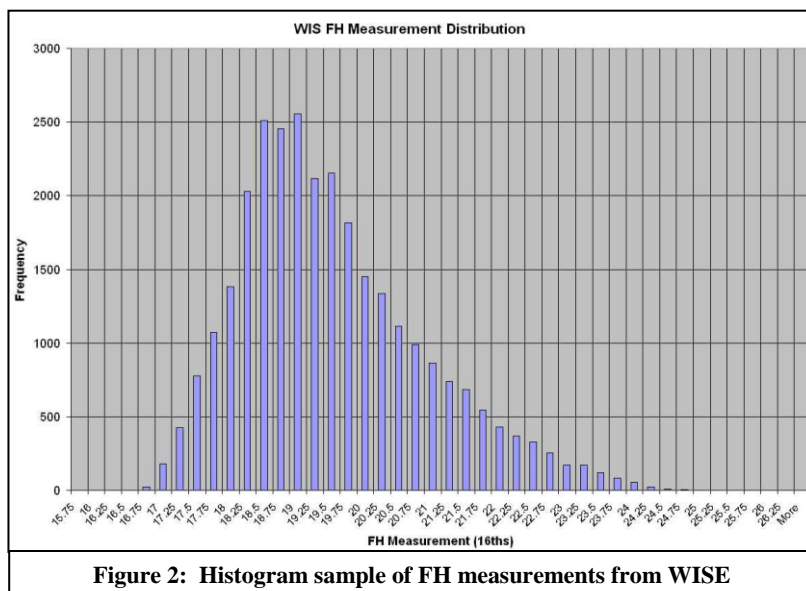
Figure 2: Histogram sample of FH measurements from WISE

Figure 2 shows a histogram for Flange Height taken from a sample of approximately 30,000 wheel measurements (about 3 days worth of measurements at Selkirk) representing a fairly normal statistical distribution. Deciding where to set the condemn limit for WISE involved evaluating the right side of this curve. If the limit of condemnation was set at 24.25-sixteenths, WISE would have sent 34 of these wheels to the wheel shop for validation, which is in line with CSX expectations. With the limit set at 24-sixteenths, which is the AAR standard limit and a difference of only 1/64-inch, WISE would have condemned **88 wheels**. Measurement errors alone, caused by things such as a dirty wheel, suggest that some portion of those 54 extra wheels would actually have passed the AAR standard of 24-sixteenths. By carefully studying the data, IEM was able to establish appropriate limits to maximize the number of condemnable wheels sent to the shop while minimizing the number that ultimately proved to be false positive.

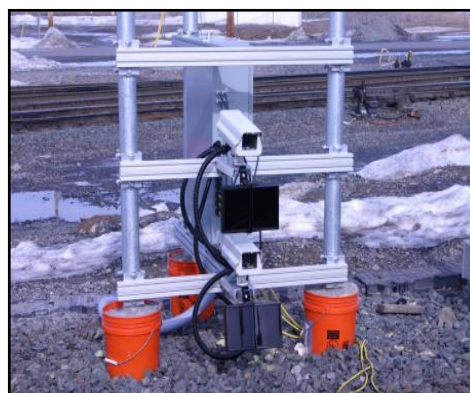
Figure 3: The BPMS module at the Selkirk installation

four wayside cameras and illuminators, a pair on each side of the car (See **Figure 3**). The first camera is positioned to view the upper portion of the brake pad and the second camera views the lower portion as visible through the truck (See **Figure 4**). The truck and brake elements are identified, and the region identified as the pad is further analyzed to produce a measurement. Measurement results that are below the AAR rules or FRA regulations are flagged for additional inspection.

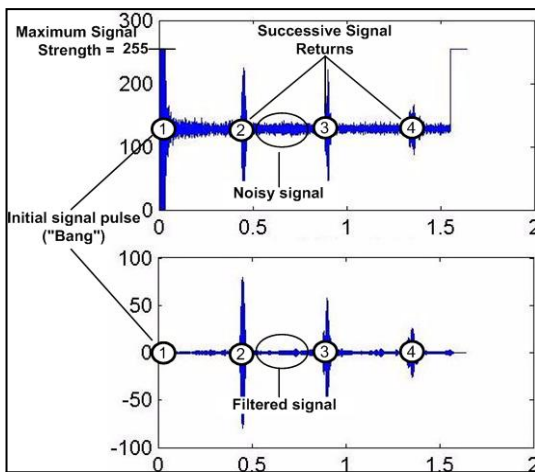
Figure 6: A noisy, unfiltered graph (top) and a filtered signal data graph (bottom)

Noise reduction software and hardware are used to reduce spurious noise caused by outside sources. **Figure 6** shows a graph with a noisy signal and a filtered signal. The bottom graph is the ideal signal with all noise reduced to negligible levels and easy to detect return signals.

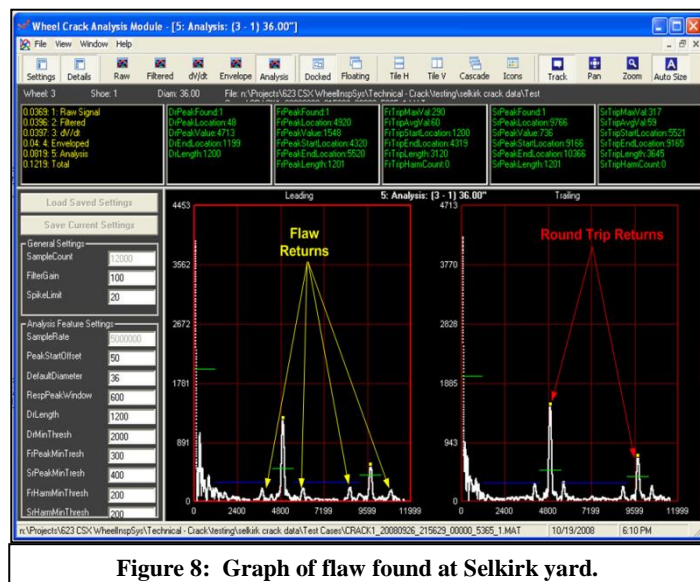
Figure 8: Graph of flaw found at Selkirk yard.

where they are expected and show as taller spikes on the graphs. The signals that were returned from the spot of the flaw are tiny fluctuations on the graph before and after the return signal. The presence of the flaw is verified in the data gathered when the wheel passed over the second shoe.

Despite spurious noise and signal variations, gathered data did show that flaws can be detected by Crack. During the testing at Selkirk, the data pattern associated with a flaw was found. **Figure 8** shows the expected pattern of a wheel with a flaw generated at Selkirk. The return signals are

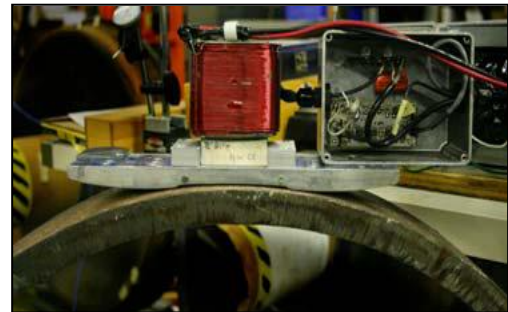
To make validation of the system more feasible, IEM developed a hand held model of the crack detection foot. During in house testing, metal loops made to resemble the tread of a train wheel are being used to test and validate the crack detection module. The foot is set on the wheel and a reading is taken (See **Figure 9**). By moving the foot along the wheel, the operator is able to use the data graphs to find the crack in the loop. The smaller returns will be closer to the expected, strong return signal as you move closer to the flaw. To test the Crack system in house, IEM utilized three loops, one with no crack and two with varying degrees of cracks. The use of a hand held foot for validation or for calibration purposes is being considered.

Figure 9: Hand held Crack Detection foot setting on testing loop

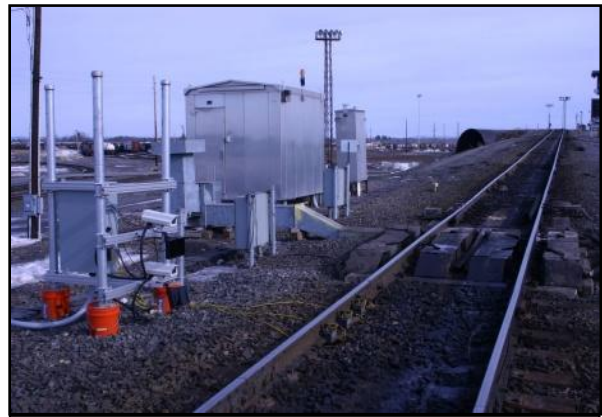
Figure 10: WISE at the CSX Selkirk location
