REPORT FHWA/NY/SR-06/148

MONITORING AND STRUCTURAL INTEGRITY EVALUATION OF COEYMANS CREEK BRIDGE FOR SUPERLOAD CROSSING

SPECIAL REPORT 148
TRANSPORTATION RESEARCH AND DEVELOPMENT BUREAU
New York State Department of Transportation
George E. Pataki, Governor/Thomas J. Madison Jr., Commissioner

Special Report 148
July 2006

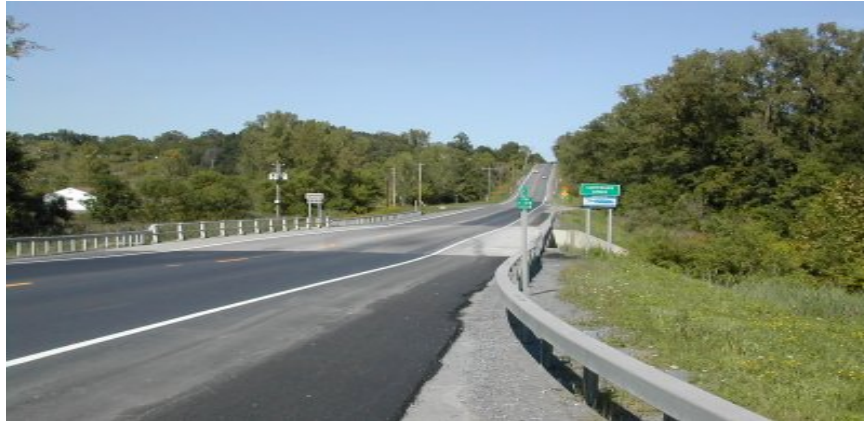
The bridge (BIN 1007560) carries State Route 9W over Coeymans Creek near the Town of Coeymans, South of Albany, NY. The bridge is a single span, integral abutment structure built in 1985. It consists of eleven 32.6-m (107.5-ft) long, adjacent prestressed concrete box beams and a 15.2-cm (6-in.) thick composite concrete deck. The 3 most interior (center) beams are 0.91-m (3-ft) wide and the remaining 8 exterior beams are 1.22-m (4-ft) wide. The interior and exterior beams [standard 107-cm (42-in) deep AASHTO box beams] were respectively prestressed using 34 and 42, 1862 MPa (270 ksi) 13 mm (1/2 in) strands. The inventory and operating ratings of the bridge are 33.5 and 86.1 metric tons (36.9 and 87.2 tons), respectively (7, 8). The condition of the deck is rated a 5 on a scale 0 to 9, signifying a fair condition with visible longitudinal cracking. The bridge span is 33.02-m (107-ft) long, and has 2 lanes of traffic. The annual average daily traffic is about 9197 vehicles. A photo and a plan view of the bridge are shown in Figures 1 and 2, respectively, and bridge beam sections in Figure 3.

Figure 1. Coeymans Creek Bridge.

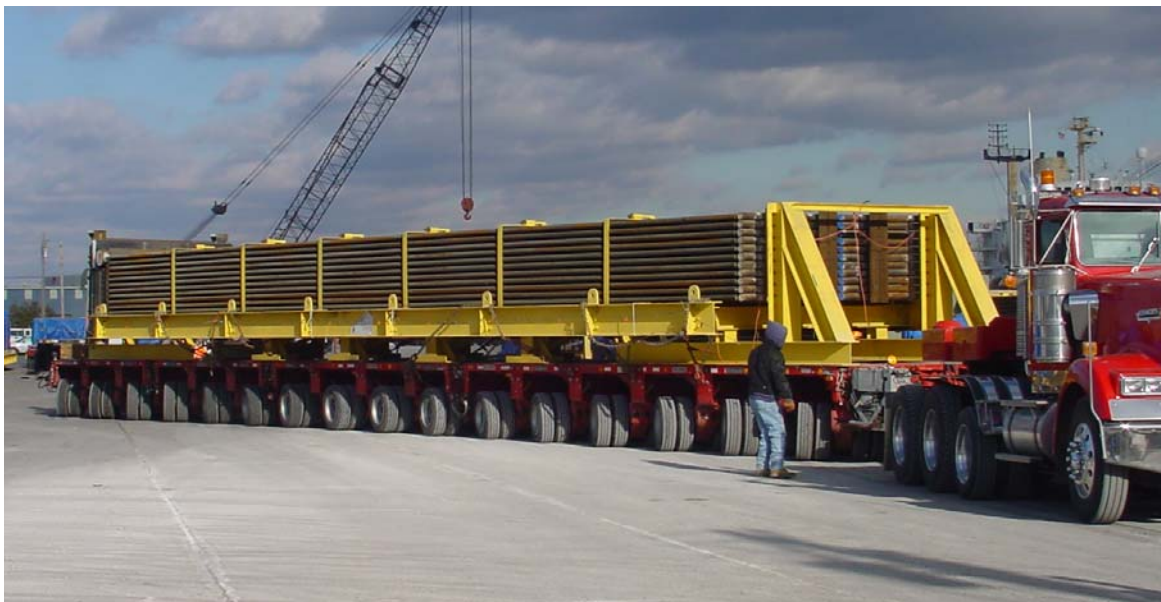
The superloads, boiler modules, ranging in weight from 369 to 1125 kN (83 to 253 kips), were carried on 16-axle trailers each weighing about 547 kN (123 kips). The trailers carrying the heavier modules were towed in a crabbed configuration across the bridge by two, 4-axle tractors/power units, each weighing about 205 kN (46 kips). Those carrying lighter modules crossed the bridge diagonally, driven by a single 3-axle tractor/power unit weighing approximately 342 kN (77 kips). Photos of a loaded trailer and driving power units are shown in Figures 4 and 5, respectively.

Figure 4. A loaded trailer.

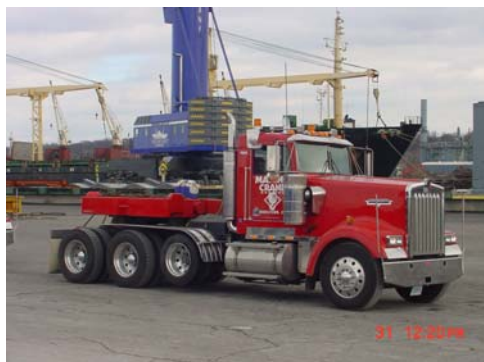
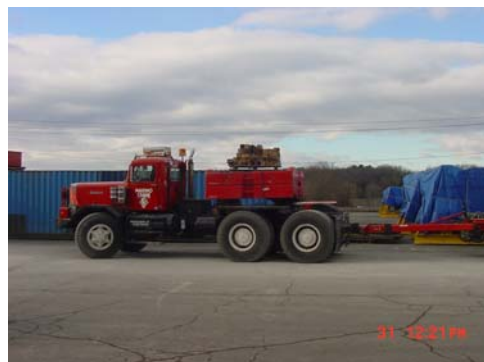
Figure 5. Driving power units.

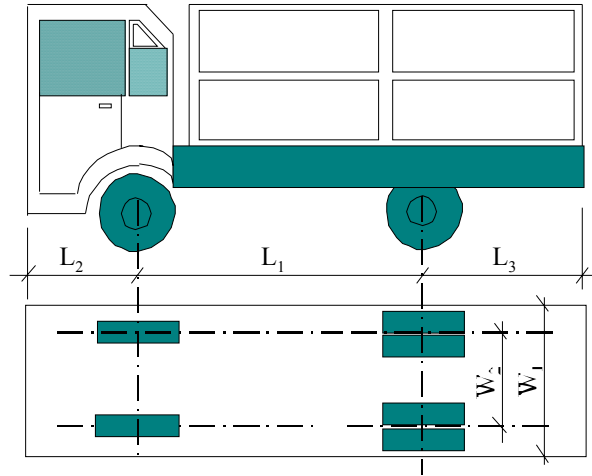
On March 28, 2002, six load tests were conducted using two of the Department's dump trucks loaded with sand. The test trucks had gross weights of 186 kN (41.9 kips) and 207 kN (46.5 kips). Each of the vehicles used in the load tests closely resembled an AASHTO M-18 (H-20) loading. Truck configurations and axle weights are shown in Figure 9, and additional information on the trucks is given in Table 2.

Truck	Length Dimensions (m)			Width Dimensions (m)	
	L ₁	L ₂	L ₃	W ₁	W ₂
A	4.57	4.85	2.36	2.62	1.96
B	4.57	2.97	2.00	2.62	19.56

Truck	Front Axle (kN)		Back Axle (kN)		Gross Weight (kN)
	Left	Right	Left	Right	
A	33.81	43.33	54.53	54.53	186.20
B	37.54	41.99	63.70	63.70	206.93

Figure 9. Load test trucks (Not to scale).

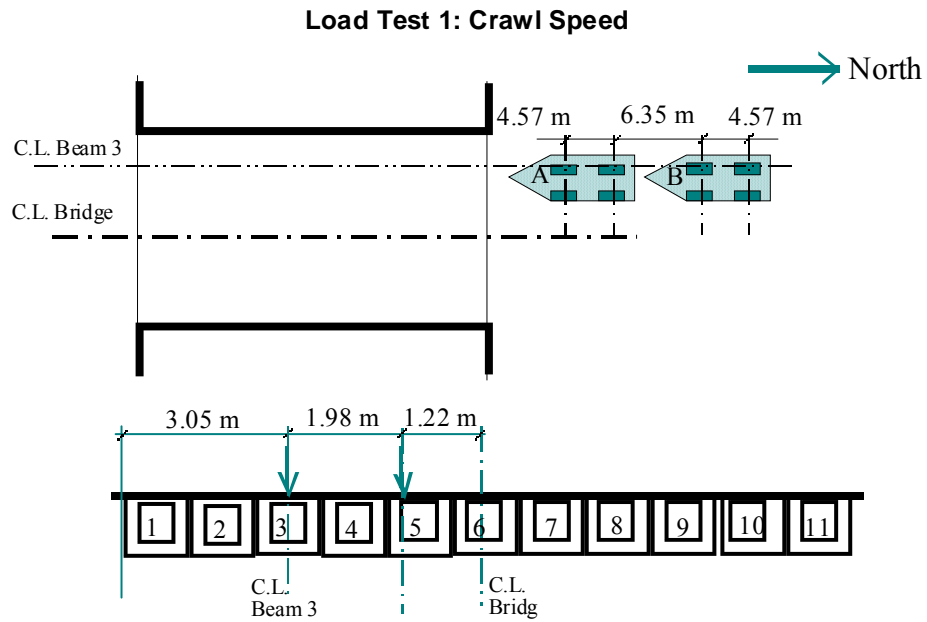
All six load tests were conducted using the two trucks in straight crossing fashion. In the first five load tests, the test trucks mimicked the superload trucks in the direction of travel (entering from the North end and exiting from the South end of the bridge) and travel speed [crossing at crawl speed (8 km/hr) (5 mph)]. In Load Tests 1 to 4, the two trucks followed each other closely (the second vehicle tailgated the first vehicle) with a wheel line directly positioned on a specific beam in each case (Beams 3, 9, 8, and 4, respectively). In Load Test 5, the two vehicles crossed the bridge in a side by side configuration, with the wheel lines positioned on the centerlines of Beams 3 and 9. The final load test (Load Test 6) was a static test, where the two vehicles were positioned with the wheel lines centered on Beams 3 and 9 (similar to Load Test 5), and the rear axle of each truck positioned at the bridge midspan. The truck positions during the six load tests are shown in Figure 10.

Figure 10. Test truck load cases. Not to scale.

Transverse load distribution plots are shown in Figures 24 to 26. The plots, generally, show expected symmetry and anti-symmetry trends. The one lane truck loadings resulted in a distribution factor of about 12 percent. The highest transverse load distribution factor (about 14 percent) was obtained for Load Test 3, the test maximizing the load applied on the east fascia beam (Figure 10).

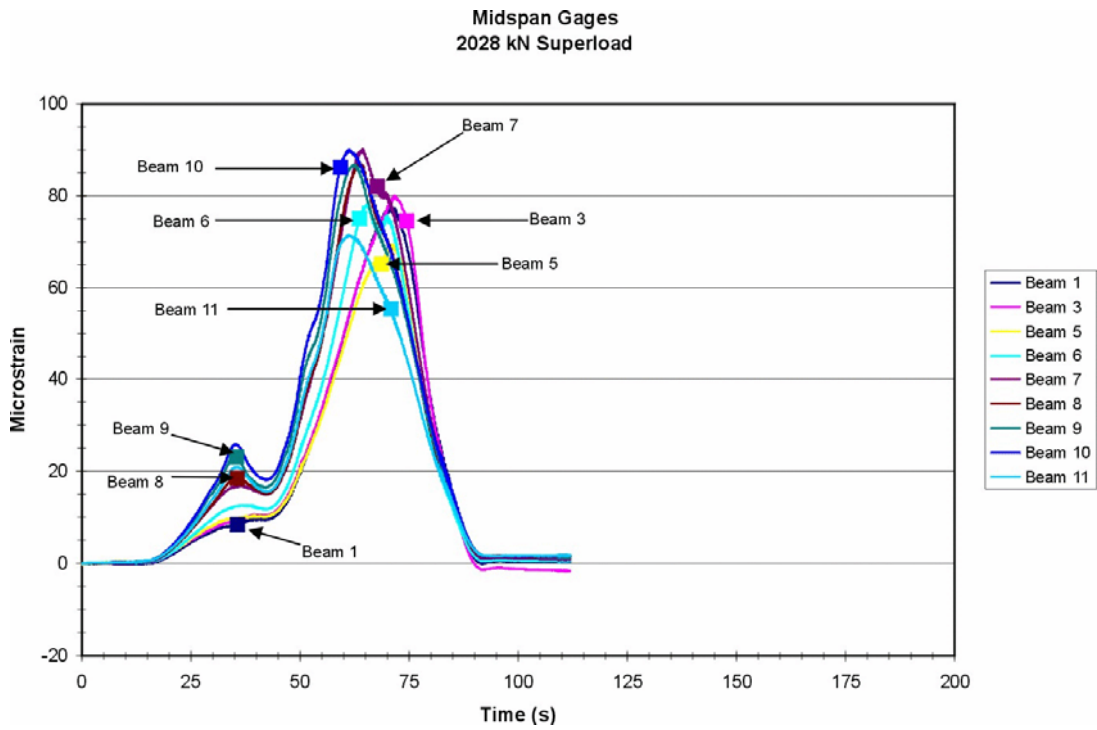
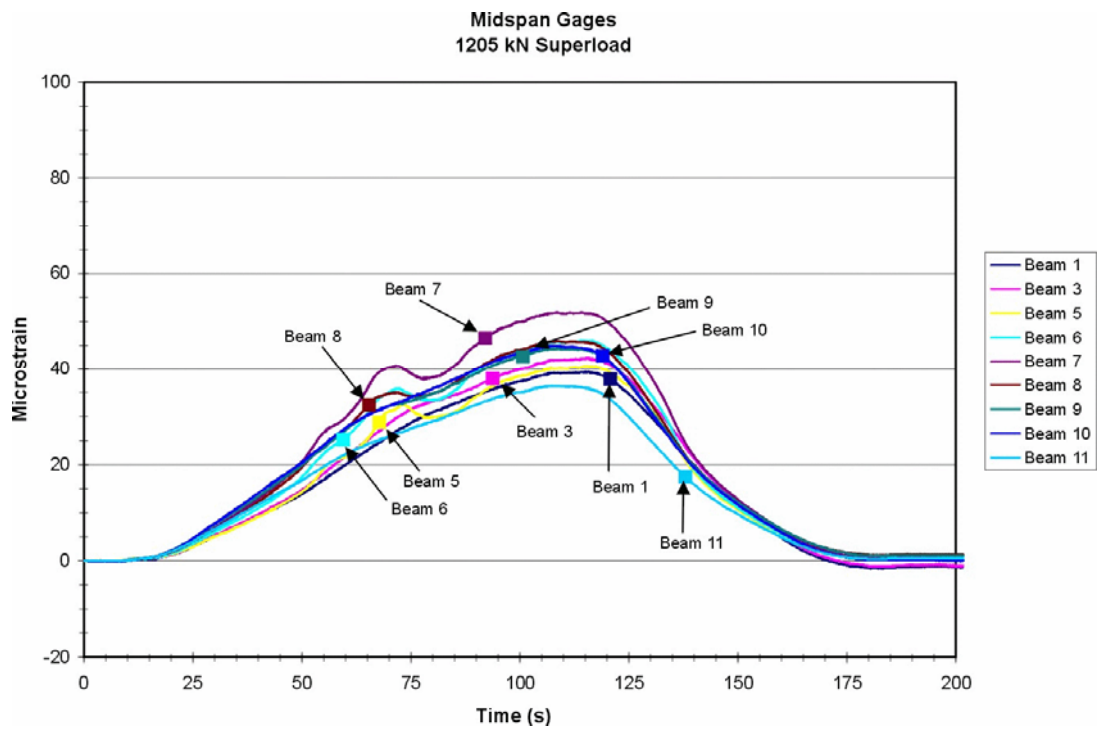
Recorded strain results at the midspans of the bridge beams during crossing of the first and second superloads are shown in Figures 11a and 11b, respectively. The highest strains recorded for the first superload was $90 \mu\epsilon$ and for the second was $56 \mu\epsilon$. Using the developed program, the times corresponding to the maximum strains in the figures were determined to coincide with the instances when a loaded trailer in each case was centered about the bridge midspan. The ratio between these strains (about 1.6) is very close to that between the weights of the loaded trailers for the two superloads (about 1.8). This implies that, when the strains were maximum, the trailers in the two crossing configurations assumed a similar orientation at the bridge midspan (about 22 degrees with the bridge centerline). Thus, it can be concluded that if the crabbed trailer, carrying the first superload, was driven diagonally, similar to the second superload, its midspan strain plot would be very close to that in Figure 11a. This conclusion is also supported by the similarity in load distribution factors, obtained for the respective superloads in the next section. The above conclusions can also be extended to the third and fourth superloads, based on the results presented in Figures 12a and 12b for those two loads.

Figure 11. Strain histories for the January 28, 2002 superloads.

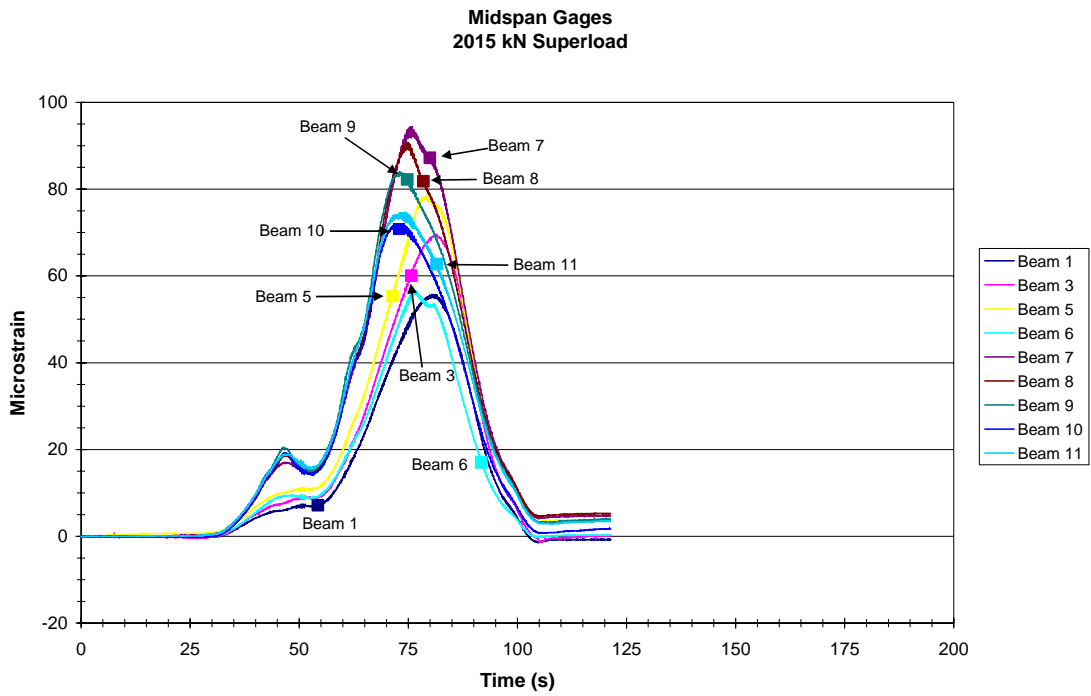
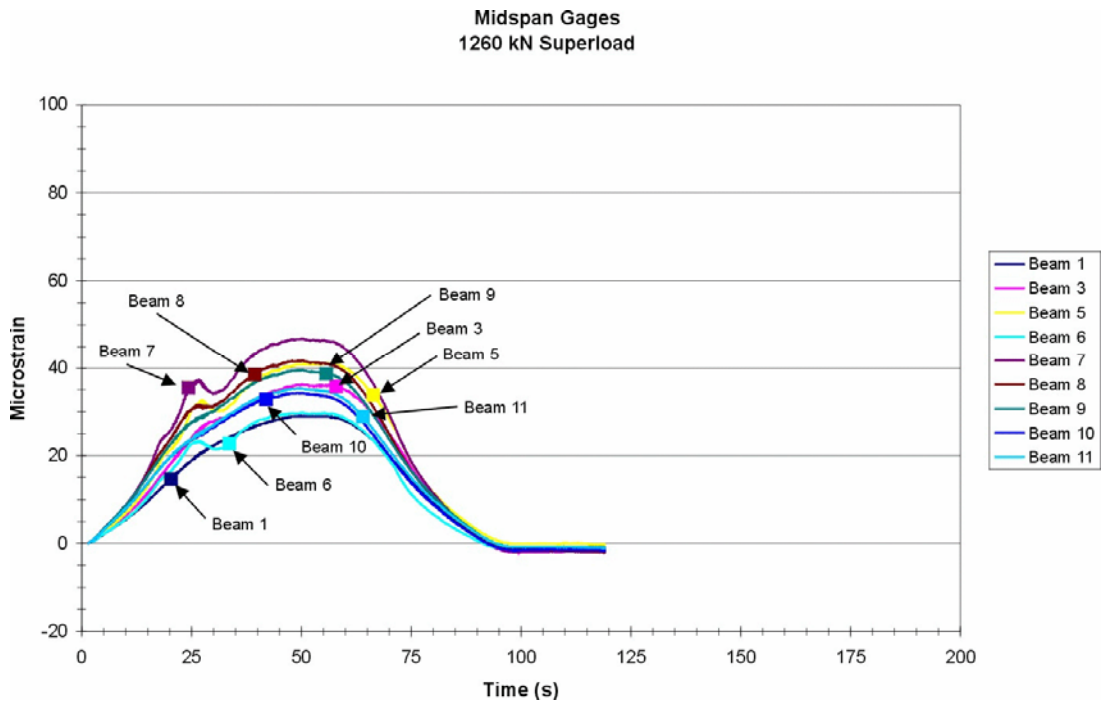
a. Third superload: Crossed crabbed.

b. Fourth superload: Crossed diagonally.

Figure 12. Strain histories for the March 6, 2002 superloads.

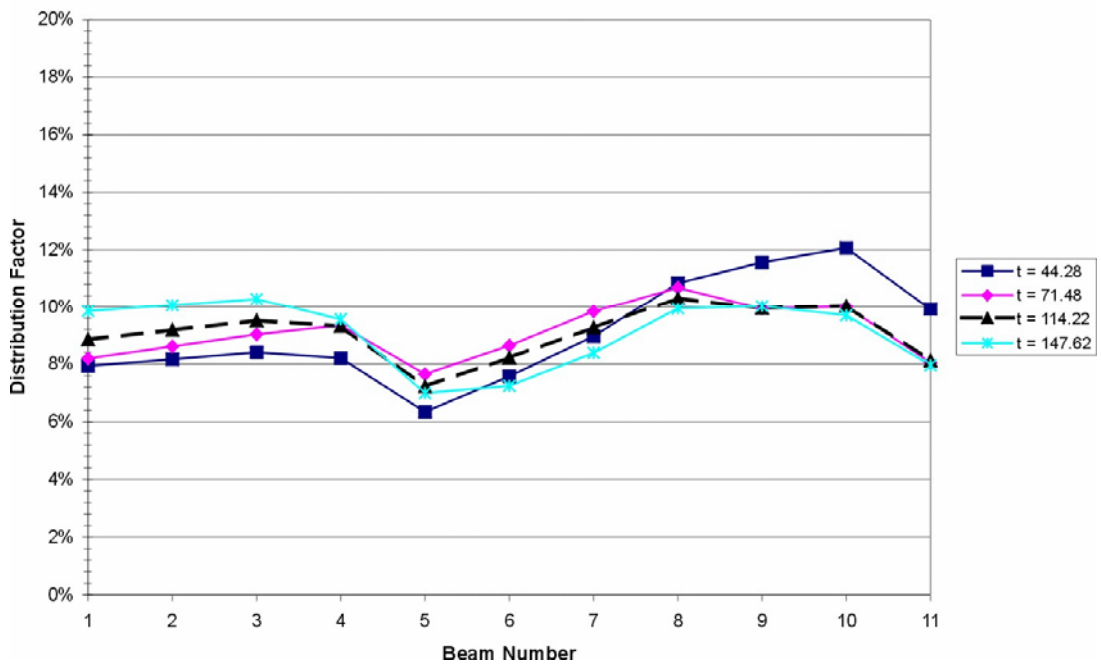
Figures 13a and 13b, and 14a and 14b, respectively, show the load distribution plots for the first and second, and third and fourth superload trucks, calculated at various times during a superload crossing. The dotted heavy lines in these plots correspond to time instances when the loaded trailers were centered about the bridge midspan. A load distribution factor is defined here as the percentage of the superload total moment carried by a beam, at any time during the slow superload crossing of the bridge. These figures also show the variation in load distribution factors for selected times during a superload crossing and good load distribution when the superload effect was maximum on the bridge. The dotted heavy lines in Figures 13a and 13b, which correspond to the times when the strains peaked in Figures 11a and 11b, clearly demonstrate similarity in transverse load distribution under the two crossing patterns. The above conclusions can also be extended to the third and fourth superloads, based on the results presented in Figures 12 and 14 for these two loads. Note that the distribution factors determined in this report for the two crossing patterns (about 0.12 of the total truck moment) are lower than those commonly used in line girder analysis, which can be obtained based on the AASHTO Standard Specifications (0.66) or the AASHTO Guide Specification for Load Distribution (0.55) (6, 8).

a. First superload: Crossed crabbed.

b. Second superload: Crossed diagonally.

Figure 13. Transverse load distribution for the January 28, 2002 superloads.

2. With respect to stress levels in the beams, there are no clear advantages of crabbing over driving the superload diagonally across the bridge. This is a consequence to the fact that similar transverse load distribution resulted for the two crossing patterns. The load distribution plots (Figures 13 and 14) for both the crabbed and diagonal loadings compare very well.

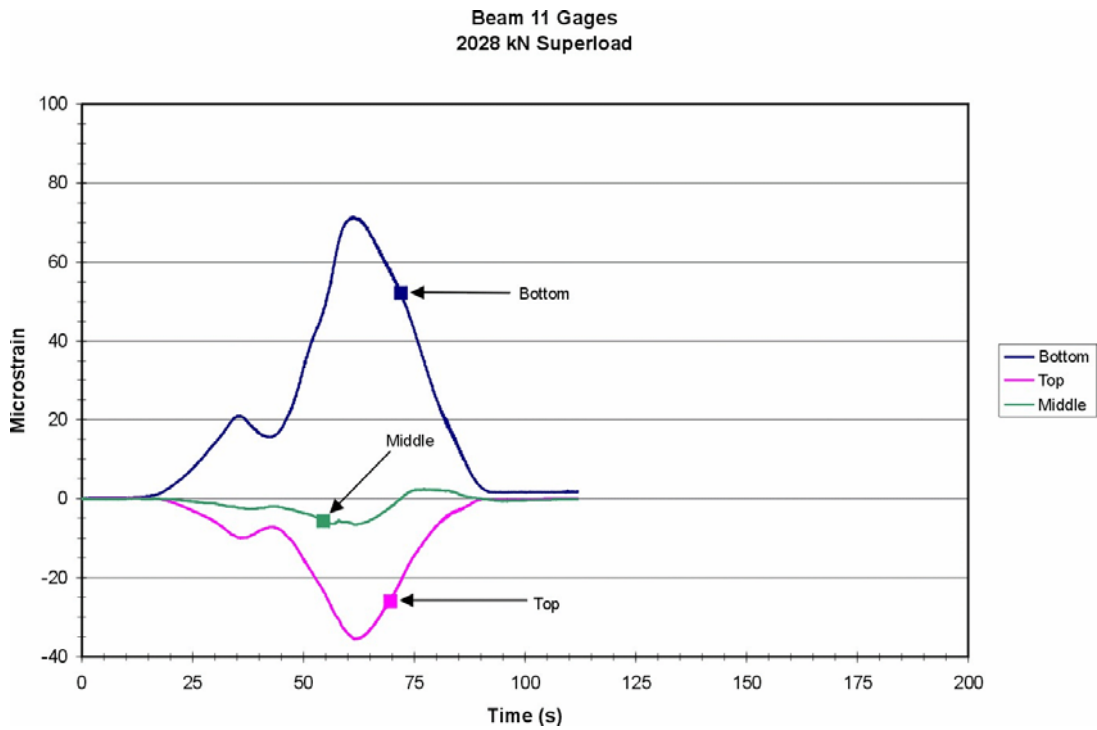
Strain data from the three gages mounted on the side of Beam 11 (Figure 15) were used in this investigation. The investigation is limited to the strain histories recorded for the first and second superloads in Figures 16a and 16b, respectively. Using this data and the calculated distribution factors in the previous section, neutral axis locations, measured from the beam bottom, and moments carried by Beam 11 can be determined. These locations and moments can be obtained, respectively, for the first superloads as 76.2 cm (30 in.) and 4.95×10^5 N-m (365 kip-ft), and for the second superload as 76.2 cm (30 in.) and 2.63×10^5 N-m (194 kip-ft). The ratio between the calculated moments (1.88) is very close to the ratio between the loaded trailers' weights (1.68), which supports the conclusion reached in the previous section when comparing the two crossing patterns.

Figure 16. Beam 11 strain histories for the January 28, 2002 superloads.

Beam 11 strain histories during Load Tests 3 and 5, the tests with the highest strains, are shown in Figure 27. These time histories may be compared with those in Figure 16 for the first and second superloads. Beam 11 results obtained using the strain histories for the two superloads and the two load tests are summarized in Table 5. For this beam, the table shows the maximum stresses, distribution factors, neutral axis locations, and midspan moments assuming both simply supported (SS) and fixed end (FE) conditions for the four loading scenarios. The highest stress in the beam due to the superloads is about 3.4 times that obtained during the testing. This ratio may be compared to that obtained by dividing the weight of the trailer carrying the superload by the weight of the two test trucks (4.3). The difference between the two is attributed to the crossing pattern. The neutral axis locations obtained under the four loading scenarios are very similar, with an average location of about 752 mm (29.6 in.), measured from the bottom of the beam. This location is higher than that calculated, theoretically, assuming an effective concrete deck thickness of 152 mm (6 in.) [648 mm (25.5 in.)]. Each of the three moments in the table is plotted against the stress column in Figure 28 to obtain a section modulus. A test-based modulus, given by the slope of the “Test” line in the figure [(0.2127 m³) (12960 in.³)], is comparable to the theoretical modulus of 0.1931 m³ (11766 in.³). From the figure, it is clear that the section modulus obtained as the slope of either of the SS or FE lines would not compare that well with the theoretical section modulus (SS would overestimate and FE would underestimate the section modulus). These findings support the previously stated conclusion on the structure’s end conditions, being somewhere between simply supported and completely fixed.

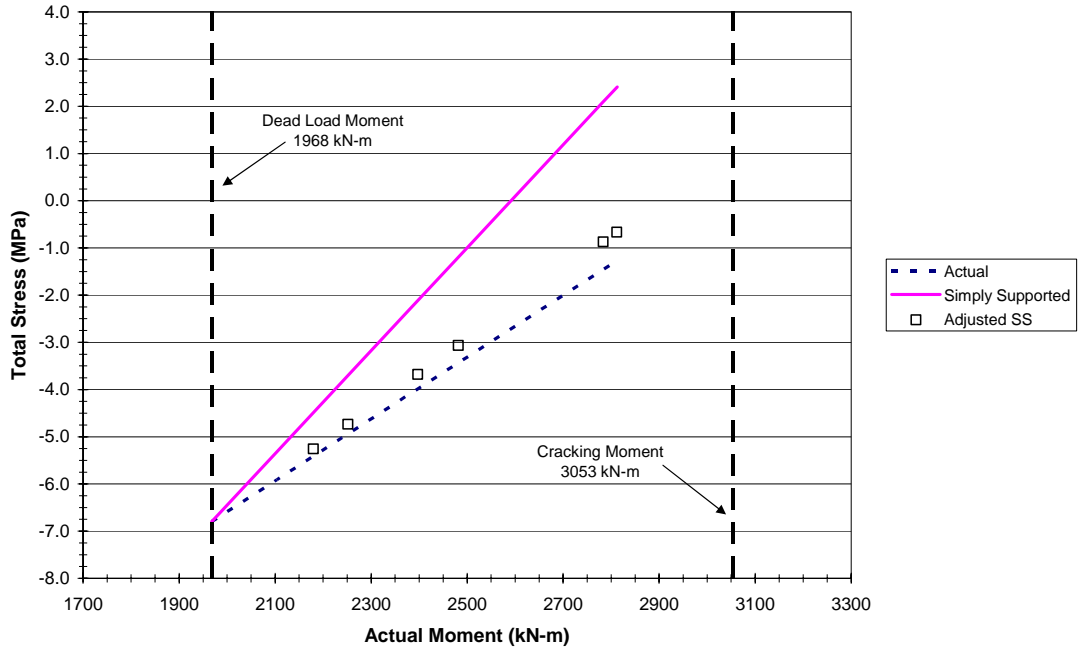
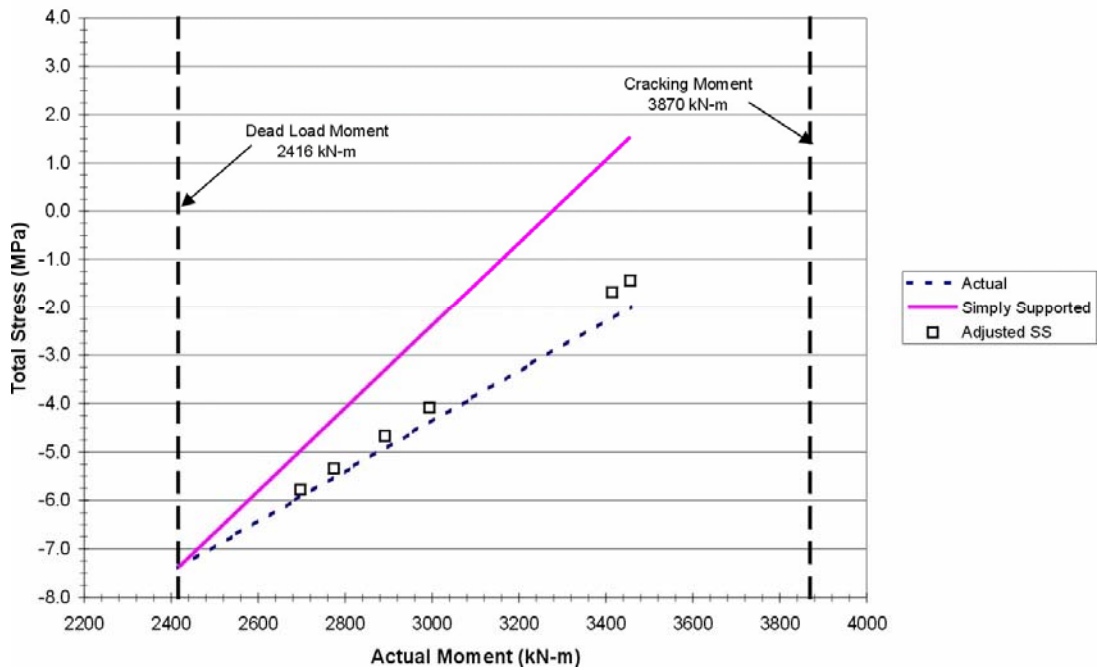
BRADD-2, Bridge Automated Design and Drafting Software, was used to determine total tensile stresses in the concrete at midspan of Beams 7 and 8, two of the most stressed beams. These stresses are plotted against the actual moment on the bridge in Figure 17. The figure shows 2 vertical lines, representing the dead load moment and the moment that would cause cracking of the beams, two inclined lines, and labeled moment stress points. In this figure, the dashed line, labeled “Actual,” represents the moments and stress levels in the beam due to dead load and superload. The solid line, labeled “Simply Supported,” represents the moment and stress levels in the beam due to dead load and superload, with the superload moments calculated analytically using the developed program simply supported solution. The small box labels, “Adjusted SS,” represent the moments and stresses for selected superloads, obtained by multiplying the simply supported moments by a factor (0.52 to 0.66) determined using the developed program. This factor reflects the effect of the integral abutments in reducing the beam’s simply supported moment. From Figure 17, it is clear that the moment in the bridge beams induced by the crossing superloads remained well below the cracking moment.

a. Beam 7 stresses.

b. Beam 8 stresses.

Figure 17. Beams 7 and 8 total stresses.

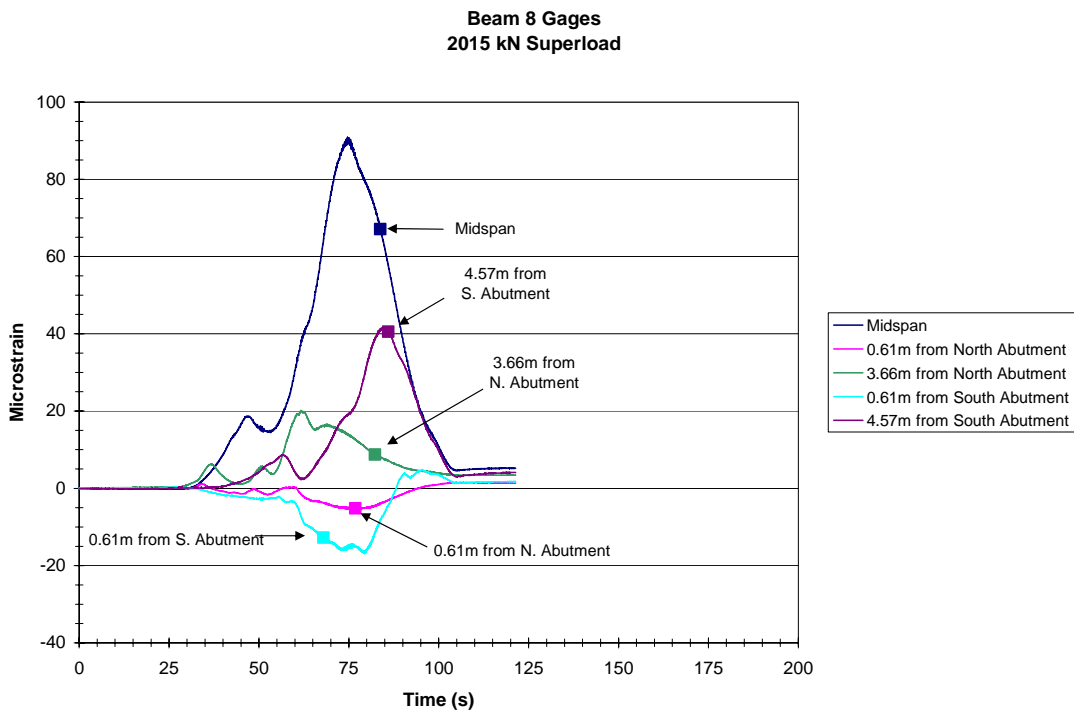
The effect of this fixity is clearly demonstrated by Beam 8 strain histories in Figures 18 and 19, noting the negative bending experienced by the beam near the abutments. Similar bending was observed for the strain history results for the first and second superloads (9). This end fixity is further illustrated in Figure 20 which compares actual midspan bridge moment for the third superload (2015 kN) to those calculated assuming simply supported and fixed end conditions. From this figure, it can be concluded that the structure behaved somewhere between being simply supported and completely fixed. Limited analysis on this beam, because of computational difficulty, showed excellent agreement between actual/measured and calculated fixed-end moments and shears.

Figure 18. Beam 8 strain history for the third superload.

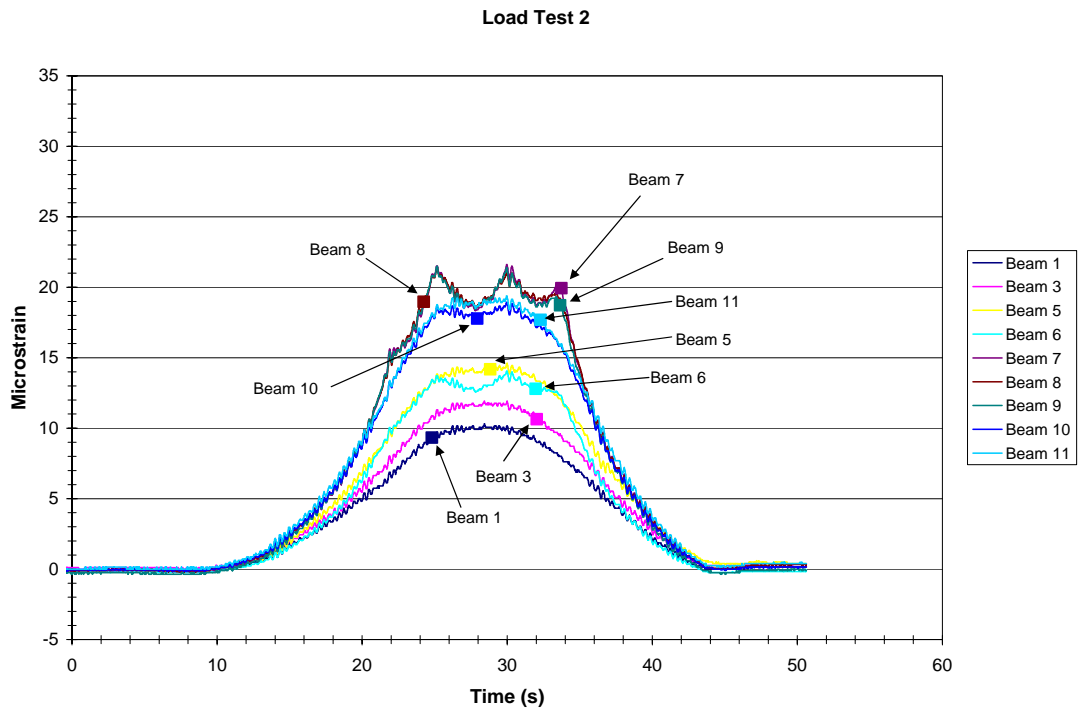
The strain histories for the six load tests are shown in Figures 21 to 23. Load Tests 1 and 2 (Figure 21) resemble one lane loaded scenarios on the west and east lanes, respectively. The strain history results for these tests clearly show that the beams directly under the trucks wheel lines were stressed most (Beams 3 and 5 for Load Test 1, and Beams 7, 8, and 9 for Load Test 2). The highest recorded strains in the two tests were within $3 \mu\epsilon$, which may be attributed to a difference in the lead distance between the two trucks as they crossed the bridge during the tests. The two time histories did not mirror image each other because the readings for the gages on Beams 2 and 4 were linearly interpolated, using neighboring gage readings.

a. Test trucks crossing at crawl speed in the west lane.

b. Test trucks crossing at crawl speed in the east lane.

Figure 21. Load Tests 1 and 2 strain histories.

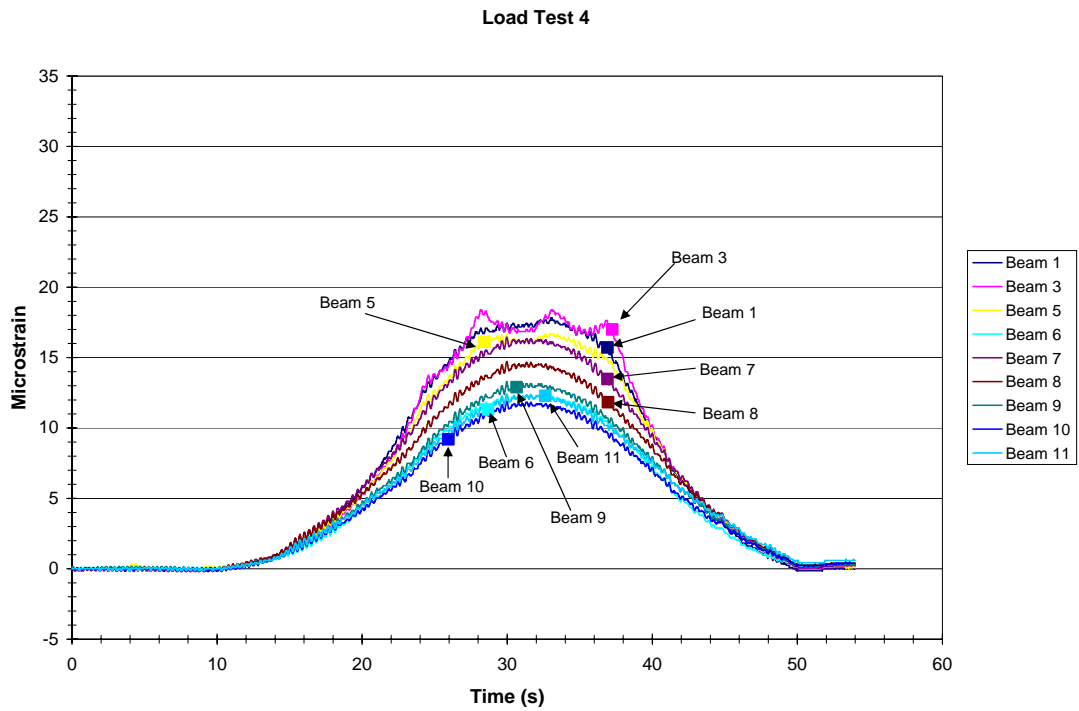
Load Tests 3 and 4 (Figure 22) were intended to maximize the load on the east and west fascia beams, respectively. The strain history results for these tests, again show that most of the load was carried by Beams 7 to 11, and 1 to 5, for Load Tests 3 and 4, respectively. The highest recorded strains during the two tests were within $6 \mu\epsilon$, which may be attributed to a difference in the lead distance between the trucks during the crossing.

a. Test trucks crossing at crawl near the east fascia beam.

b. Test trucks crossing at crawl near the west fascia beam.

Figure 22. Load Tests 3 and 4 strain histories.

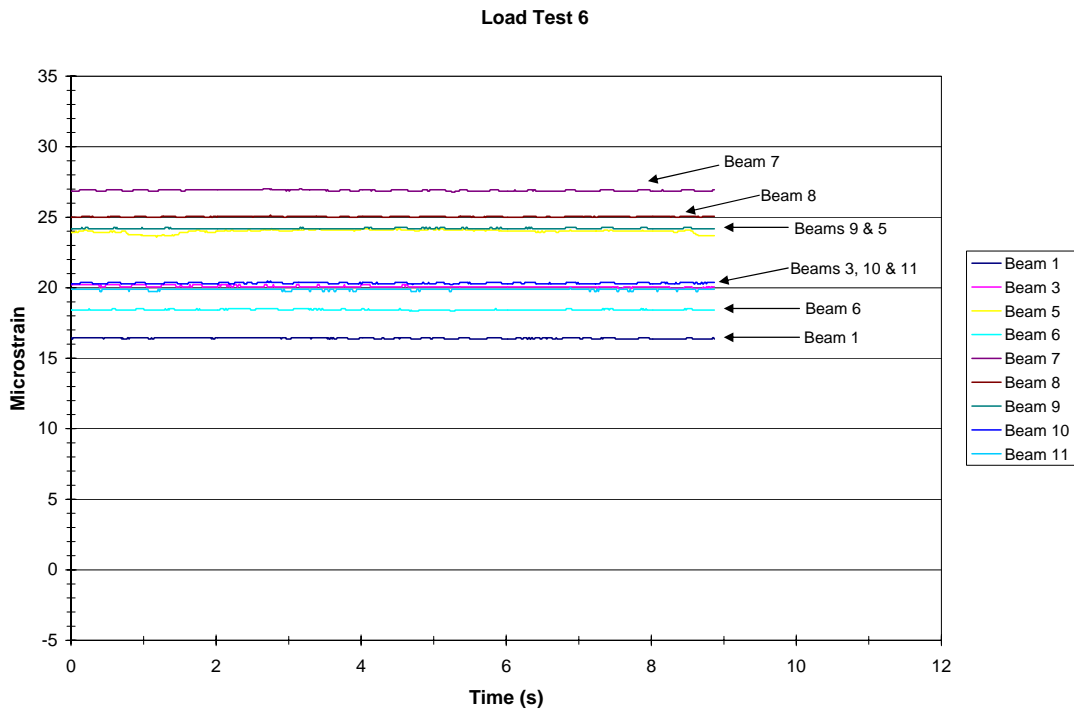
The strain histories for Load Tests 5 and 6 in Figure 23 represent the two trucks in side by side formations, moving at a crawl speed (Load Test 5) and statically positioned at the bridge midspan (Load Test 6). The strain history results for the two tests show that Beams 3 to 5 and 7 to 9 were the most stressed, with the highest strains in the two tests within $4 \mu\epsilon$.

a. Test trucks crossing side by side at crawl speed down the bridge center line.

b. Test trucks statically positioned side by side at the bridge midspan.

Figure 23. Load Tests 5 and 6 strain histories.

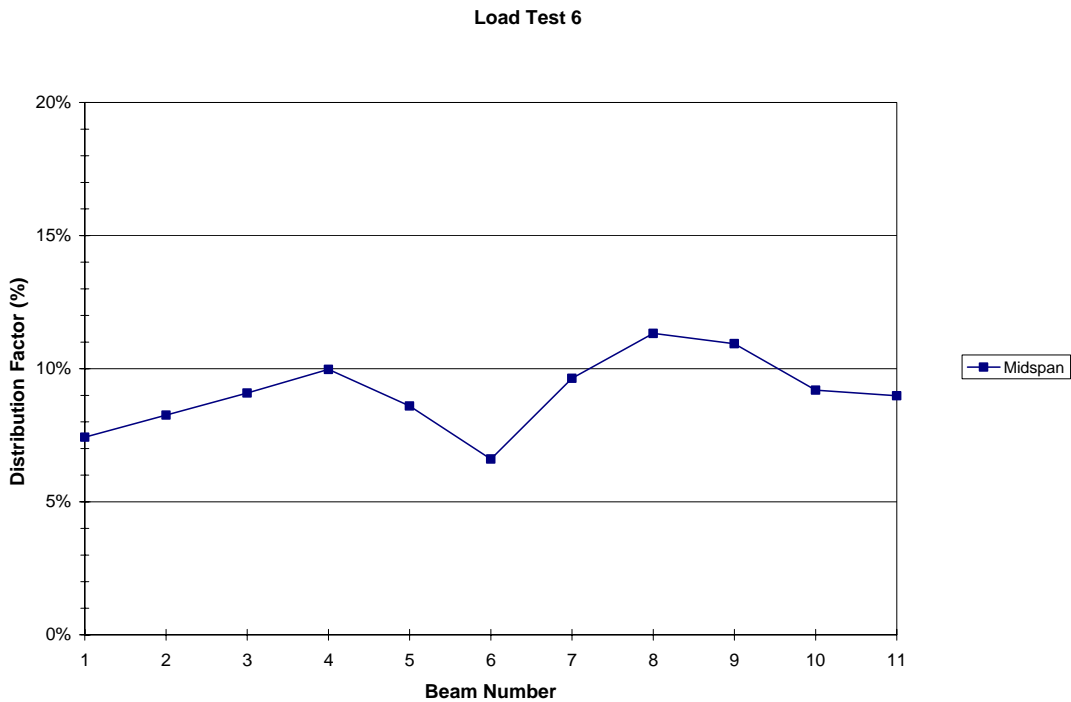
a. Test trucks crossing side by side at crawl speed down the bridge center line.

b. Test trucks statically positioned side by side at the bridge midspan.

Figure 26. Transverse load distribution for side by side formation truck crossing.
