REPORT FHWA/NY/SR-03/139

# In-Service Evaluation of a Concrete Bridge FRP Strengthening System

Special Report 139  
March 2003

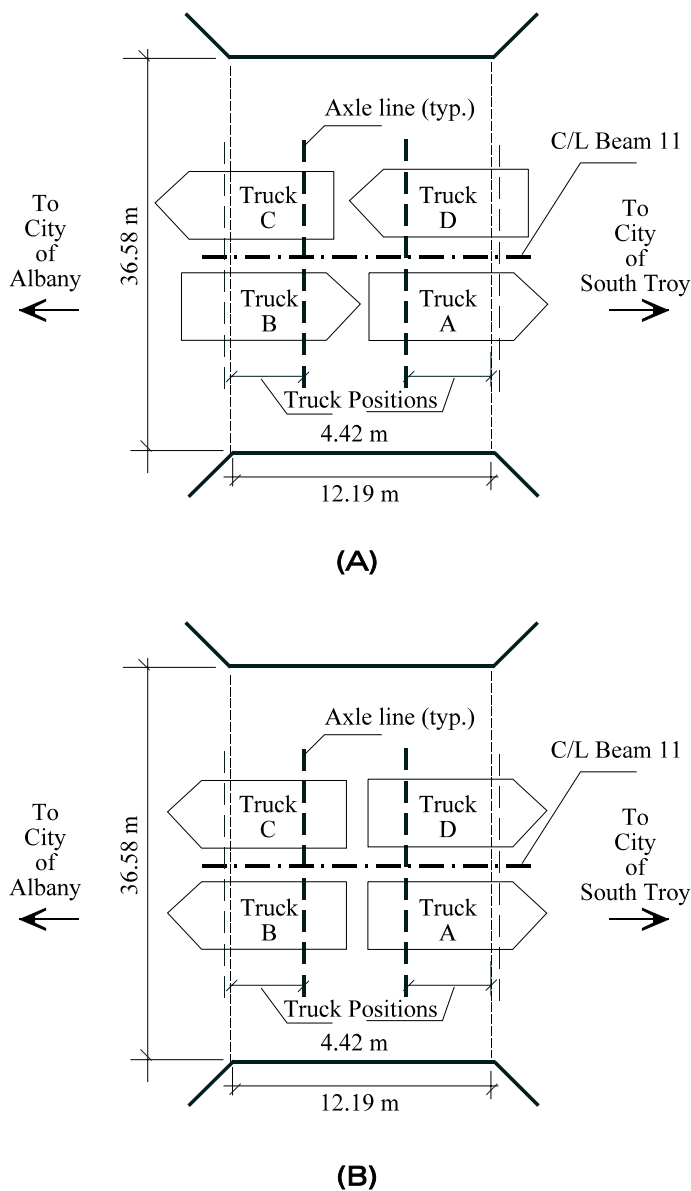
**FIGURE 8. Typical truck positions on the bridge: A) Straight and B) Back-to-back.**

The 2001 testing was conducted using similar trucks and loading sequences to those used in the 1999 test. The average weight of each of the test trucks was approximately 196 kN (44 kips). The sequencing, in which the four trucks were designated A through D (Figure 8), consisted of Truck A, Trucks A+C, Trucks A+B+C, Trucks A+B+C+D, Trucks B+C+D, Trucks B+D, and Truck D. Since the load carrying capacity of the bridge is now known with a great degree of certainty, in the November 2001 test, only the 4.42 m position (Figure 8) from the 1999 test was used in straight and back-to-back configurations (2). The total moment on the bridge due to all 4 trucks parked back-to-back at this position was about 2.75 times that induced by MS-18 loading (6).

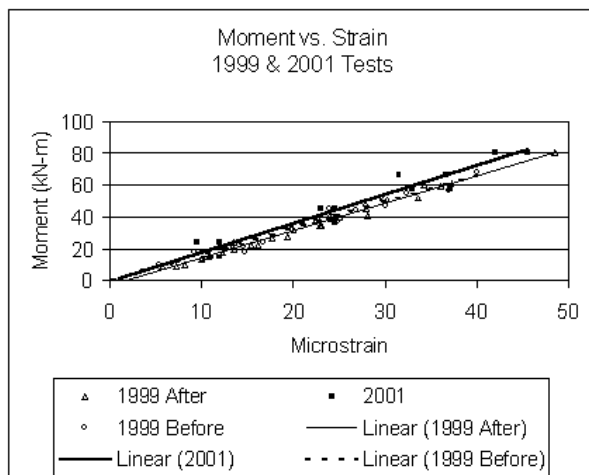
**FIGURE 9. Strain vs moment comparisons.**

Recorded strains on Beam11 from the 1999 before and after strengthening, and the 2001 load tests are plotted against truck moments in Figure 9. This figure shows that the 2001 test, generally, resulted in lower strains than those obtained during the 1999 test, and that the changes in beam stiffness during the three tests (before strengthening, 1999, and 2001) are very small. The figure also illustrates linear behavior and consistency of the collected strain data during the three tests.

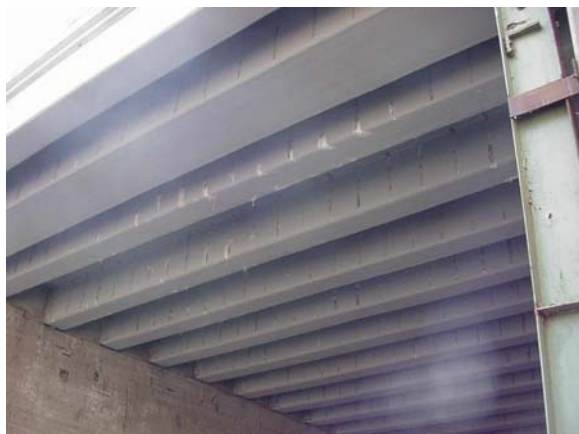
**FIGURE 15. South side beams: A) Photo and B) Thermographic image.**

Strain compatibility can be used to assess the bond quality between the FRP laminates and concrete, by observing laminate and concrete strains at similar locations on a structure. Such a comparison at two locations, above and below the neutral axis, is shown in Table 1 for Trucks B+C+D (for maximum shear at midspan) on the bridge. Bottom concrete strains for comparison with Gage F-32 strains were calculated using Gage S-4 readings and an average location of the neutral axis. Comparing the respective percent differences for the 2001 and 1999 tests, it can be concluded that quality of the bond, at the instrumented locations, has not deteriorated during the last two years in service. Thermographic imaging using an Infrared (IR) camera did not show any serious debonding in the system laminates. Upon close observation, only small bubbles were detected in some of the camera images. A photo and a typical thermographic image of the South side beams are shown in Figures 15A and B, respectively.

In November 2001, the bridge carrying Route 378 over the Wynantskill Creek in New York, was load tested to monitor changes in the bridge FRP retrofit system, after being in service for two years. The system was installed in 1999 to contain freeze-thaw cracking and improve flexural and shear behavior of the deteriorated reinforced-concrete T-beam bridge structure. Changes in the quality of the bond between the FRP laminates and concrete, at instrumented locations were investigated, and those in the retrofit system were studied by observing changes in transverse load distribution, effective flange width, and neutral axis location. The 2001 load test indicated that recorded strains were generally lower than those measured during the 1999 test. The results also indicated that the quality of the bond between the FRP laminates and concrete, and effectiveness of the retrofit system have not changed after two years in service. Thermographic imaging using an Infrared camera, provided images which supported this conclusion on bond quality.
