REPORT FHWA/NY/SR-01/135

Strengthening of Route 378 Bridge Over Wynantskill Creek In New York Using FRP Laminates

Special Report 135
March 2001

This report describes application of Fiber-Reinforced Polymer (FRP) composite laminates to strengthen an aging reinforced-concrete T-beam bridge in South Troy, Rensselaer County, New York. Leakage at the end joints of this single-span structure led to substantial moisture and salt infiltration in the bridge superstructure. Presence of efflorescence was observed, and freeze-thaw cracking and concrete delamination at some locations on the beams were noted. Concerns about integrity of the steel reinforcing and overall safety of the bridge were raised. These concerns were heightened by the absence of any documents pertaining to the bridge design, such as rebar size, steel type, concrete strength, and design loads. Thus, a decision was made to strengthen the bridge using bonded FRP-laminates. Load tests were conducted before and after the laminates were installed to evaluate effectiveness of the strengthening system, and investigate its influence on structural behavior of the bridge. Results from these tests and those obtained using classical

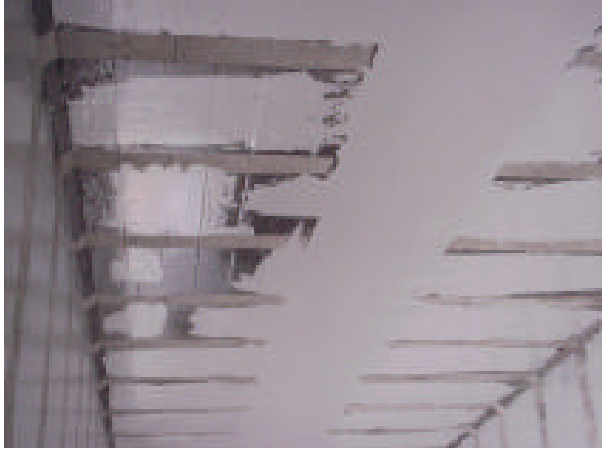
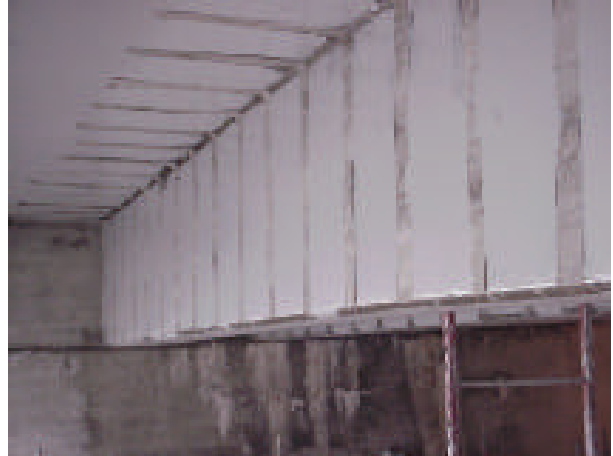
Figure 4A. Primer and putty applied at marked locations.

A primer was applied followed by a putty at the locations where the FRP laminates were to be installed (Figure 4A). The primer is expected to penetrate the concrete surface, increase its strength, and improve laminate bonding to the surface [26]. After primer application, gaps and pinholes greater than 1 mm can be seen on the concrete surface. The putty application smoothed the surface by filling the gaps and pinholes.

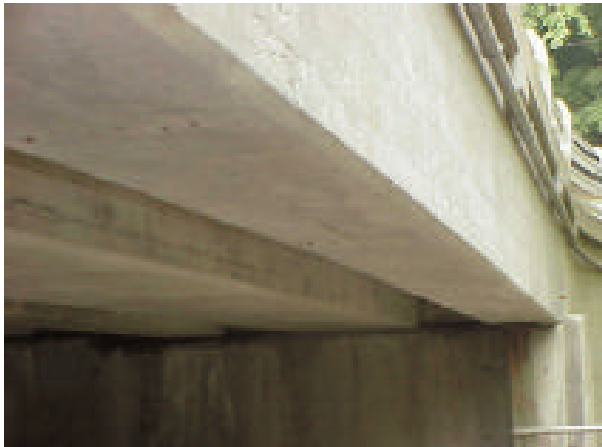
Figure 4B. Installed FRP-laminate system in place (painted to match concrete color).

Finally, the FRP laminates were painted, with TAMMS Duralkote 240 paint, for protection from ultraviolet light and aesthetic reasons (Figure 4B). Based on the installation temperatures and resin system applied, the manufacturer recommended a 7-day minimum cure time. The after load test was conducted 10 days after the laminate installation was completed.

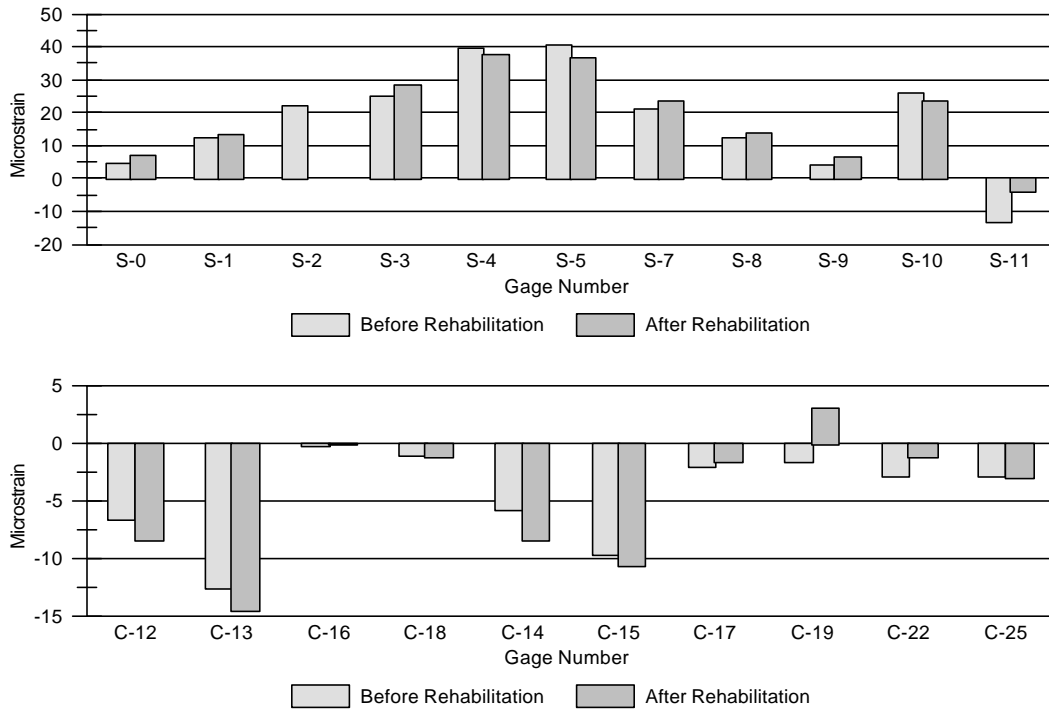
Figure 13. Recorded strains in the before and after tests for gages mounted on steel rebar and concrete (all 4 trucks parked at 4.42-m position).

Before and after installation strains for gages mounted on steel-rebars and concrete for all 4 trucks (Trucks A+B+C+D) at the 4.42-m position on the bridge are shown in Figure 13. Similar results for the after installation strains for gages mounted on the laminates are shown in Figure 14. Comparing the before and after readings for gages mounted on the steel rebars (Figure 13), it can be concluded that installation of the FRP laminates slightly reduced rebar stresses. Relatively higher rebar strains after installation of the FRP laminates may be attributed to random variations and minor changes in truck positions during the testing.

Gage S-11, located 0.914-m from the Albany side abutment at the bottom of Beam 11 (see Figure 13), consistently measured negative (compressive) strains indicating end fixity of the beam. This was later verified through back-calculation of moments based on measured strains, and was attributed to malfunctioning of the expansion bearings. Malfunctioning of expansion bearings is known to cause such fixity, which substantially reduces live-load moments. For example, Beam 11 moment with all four trucks positioned at 4.42 m from the abutments was reduced from 209.10 (based on simply supported conditions) to 75.93 kN-m. This may be compared to 79.72 kN-m calculated based on recorded strains. Comparing the FRP strains in Figure 14 with those recorded on the rebars (Figure 13), it can be concluded that laminate strains for some gages were lower than expected. Since the laminates were physically located below the main rebars in the beam section, strain compatibility would require laminate strains to be higher than rebar strains.

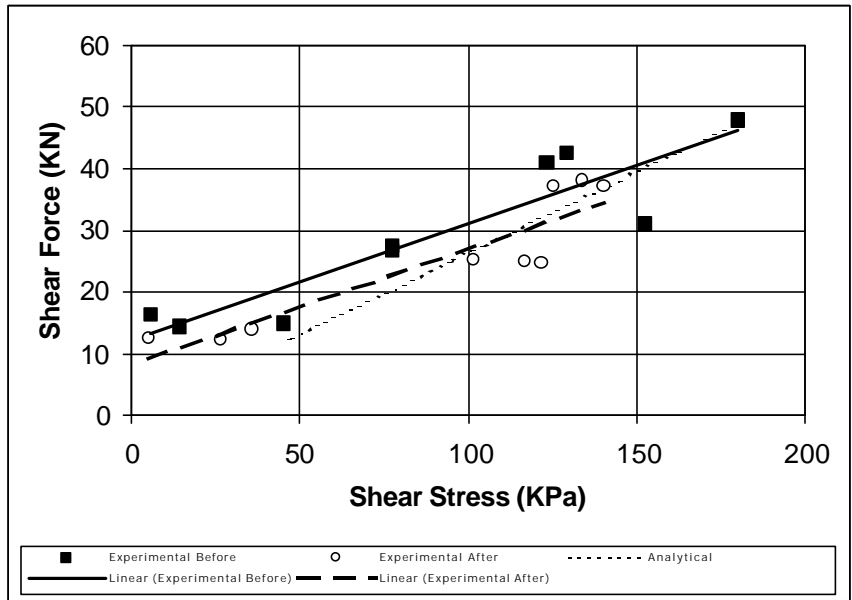
Figure 19. Shear force versus shear stress: Classical analysis versus those based on test results.

Figure 19 shows measured shear stresses for the before and after laminate installation plotted against applied shear forces. Shear stresses and forces were calculated using data from strain gage rosettes and applied truck loads. Comparing the before and after installation linear fit lines in Figure 19, a slight increase in concrete shear stress is noted after the laminates were installed. However, presence of the U-jacketed laminates is expected to provide confinement of web concrete and shear-resisting interlock mechanism, hence improving its ultimate shear capacity [19, 20, 21]. Comparison of either of these lines with the analytical prediction line, which is based on classical analysis, in the figure indicates good agreement between the experimental and analytical results. Linear behavior is also noted under both approaches. A more detailed investigation of shear behavior was not possible because of the uncertainty of steel stirrup size and placement, and the quality of the cracked web concrete.

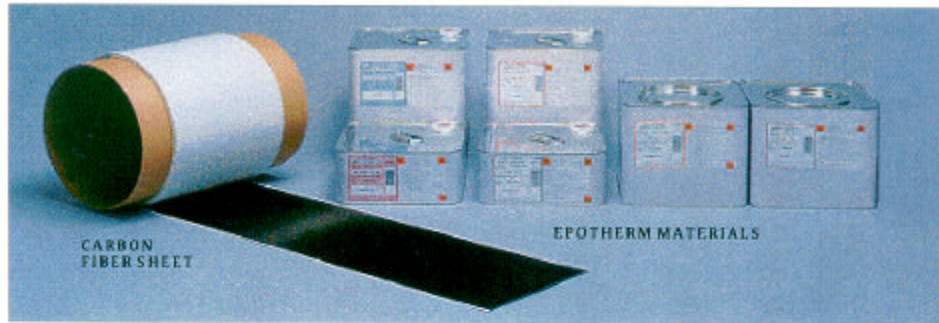
The REPLARK™ SYSTEM consists of the carbon fiber sheet and three types of EPOTHERM materials, primer, putty and resin, all manufactured exclusively by Mitsubishi Chemical Corporation, as shown in the picture below.
